# Conservation of Ancient Dagobas in Sri Lanka.

W. N. G. Silva

**Abstract:** This paper relates a description of the conservation and restoration works carried out on ancient stupas (dagobas) of Sri Lanka during the past two centuries. The main focus is on the application of engineering techniques while heeding archaeological requirements, in attending to these massive masonry edifices, during the latter part of the 20th century. The Post-restorational failure of the Mirisavetiya Stupa is taken as an example to highlight causes of failure, and how this event coupled with archaeological requirements led to the shift from complete restoration to conservation of other major stupas such as Jethwanaramaya and Abhayagiriya, is described. Further, application of modern engineering techniques used in circumventing imminent failure of earlier restored stupas such as Tissamaharamaya is described.

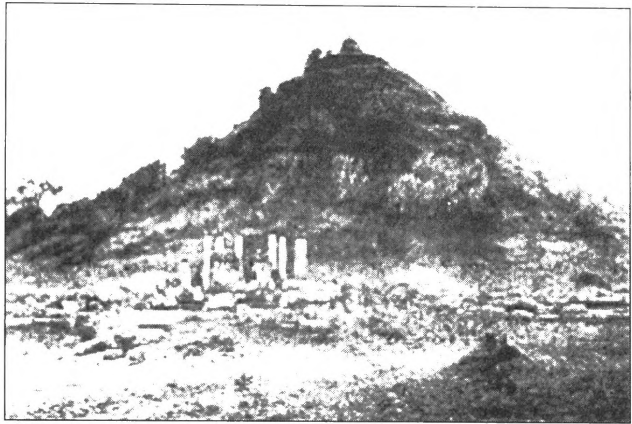
*Mirisavetiya - Before restoration*

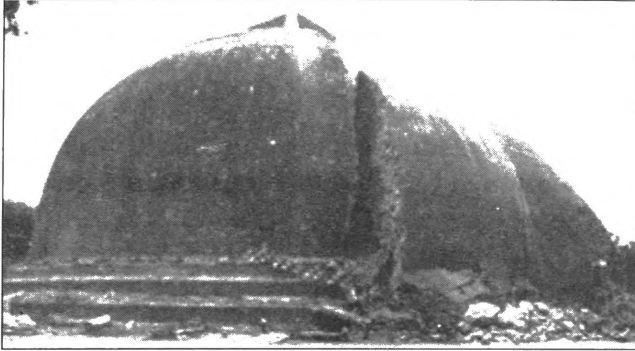
*Mirisavetiya - Failed restoration - 1980*

In this attempt the original brickwork had been stripped only to a depth of 2.5 feet from the outer face at the base. It was the opinion of the engineers that the main reason for failure of the dome was the crushing of the new brickwork at its base, which was only 2-3 feet wide. It was also the opinion of the experts that total mass of new brickwork of the dome was made to bear on the base through an arch action on contraction of the ancient brickwork done with clay binder. Inadequate cleaning of decayed old surface brick work, improper keying of bricks between the old and the new, non inclusion of the proposed number of RC rings, (one instead of six), ingress of water into old brick work during and before construction were thought to be other possible contributory factors.

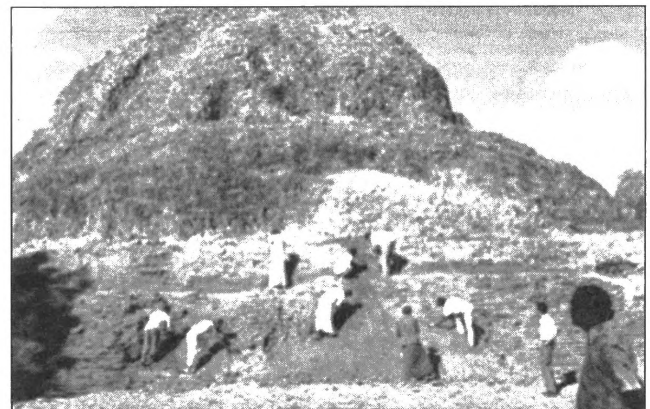
*Mirisavetiya - All ancient brickworks carefully removed*

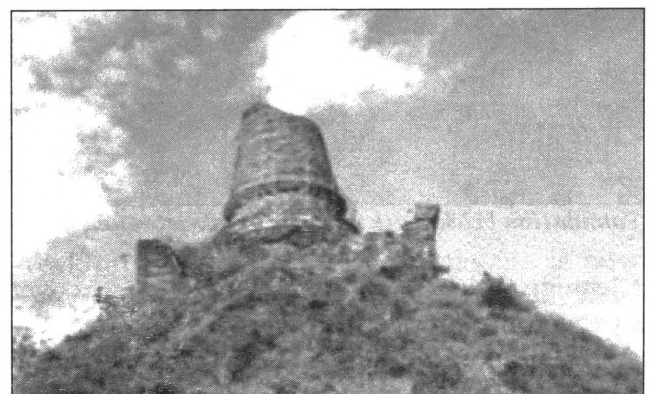
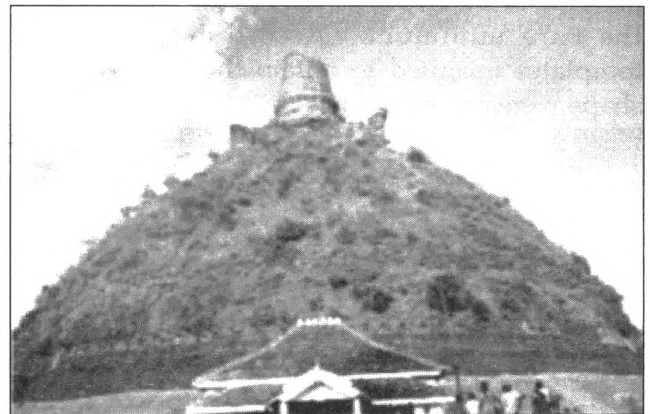
*Jethawanaramaya - Completely detached face of one side of Hatareskotuwa*

All these new discoveries as well as the structurally impaired Hatareskotuwa walls led the Director General of Archaeology (assisted by an advisory committee of eminent archaeologists) to request the Central Cultural Fund to remove additions by the English conservators and to re build the outer sections of Hatareskotuwa on all four sides leaving certain ancient original brick work on some walls.

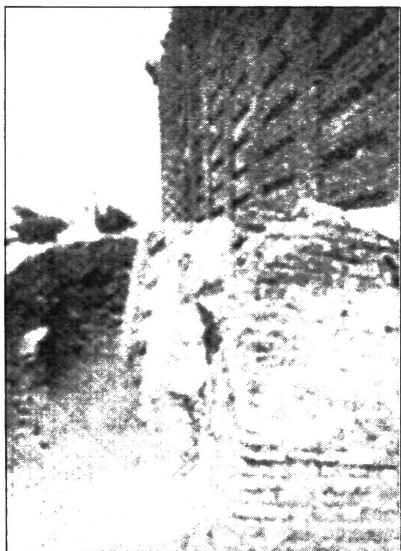
Segments of ancient brickwork unearthed in these excavations showed certain aesthetic features that had not been incorporated into the previously conserved Hatareskotuwa. There were also large gaping cracks on two remaining sides of the Hatareskotuwa walls.

*A segment of the old Hatareskotuwa missed by the English conservators uncovered in recent excavations*

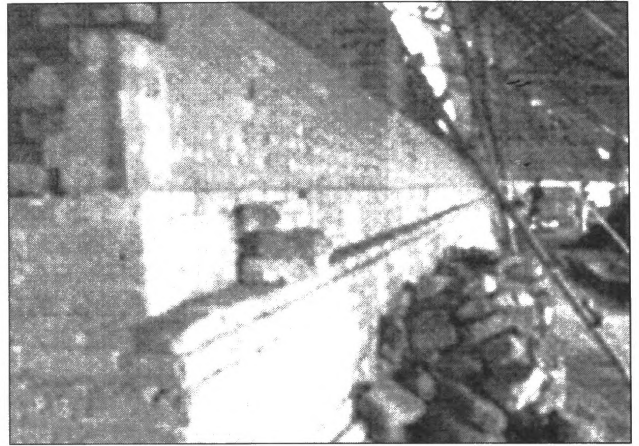
*Conservation works on the Hatareskotuwa. Hatareskotuwa too is being conserved presently and it is evident that some additions during the last conservation attempt would have to be removed since they have been laid on loose and decayed ancient brick work.*

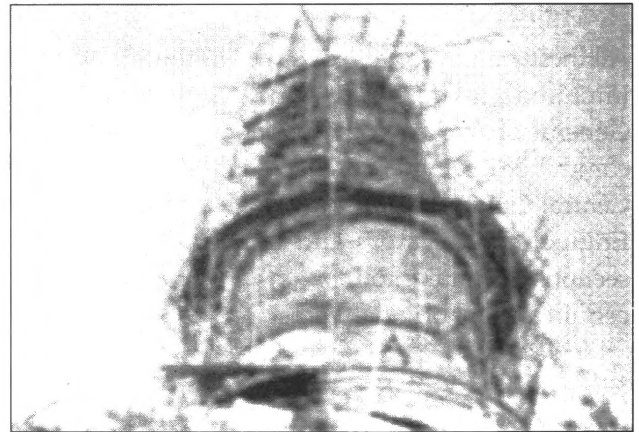
*Conservation works of the Kothkerella-Abayagiri Stupa*

*The Kothkerella which was in a very bad state has already been conserved.*

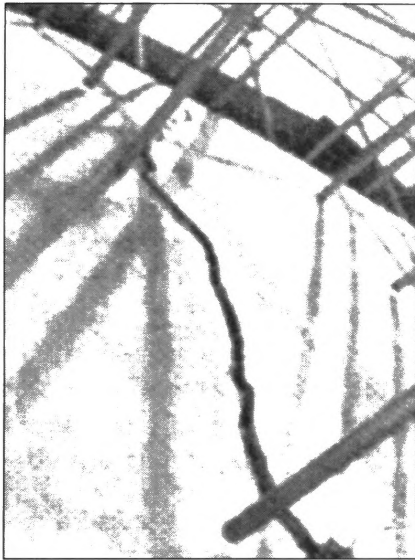
Two other failures of restored dagobas have been reported recently. They are Tissamaharama stupa restored in last decade of 19th century and a another small stupa close by called the Sandagiri stupa, restored during the last two decades. Tissamaharama stupa showed a large number of vertical cracks evenly spaced around the dome around 15 years ago. Cracks also appeared on sections of the Hatareskotuwa. The cracks were so large that engineers were of the opinion that a collapse was imminent.

At the request of the Department of Archaeology, the State Engineering Corporation proposed a series of steel or RC rings spaced at suitable intervals on the dome as an emergency measure. Two RC rings were constructed at the top of the dome initially. However, it was the opinion of some experts that even removal of certain bricks on the surface on the dome to build the RC beam was not acceptable.

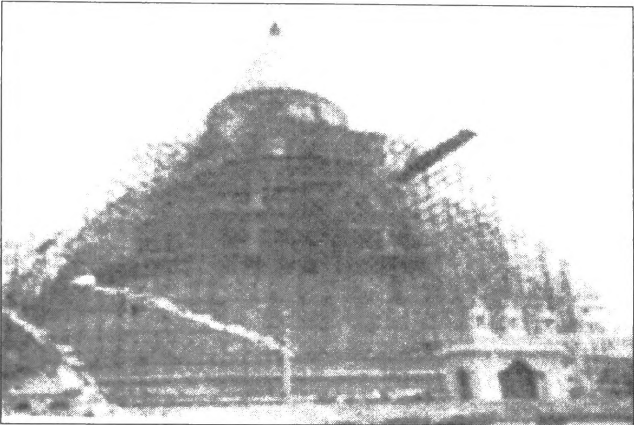
*External stainless steel prestressed cables and stainless steel bearing pads*

Therefore post tensioning the dome from the surface with stainless steel cables running over stainless steel plates (pads), spaced around dome was attempted as a desperate measure.

The segment of the Hatareskotuwa that showed early signs of separation too had been externally tied up. This intervention has since decreased substantially the rate of propagation of cracks on the dome and would perhaps cease eventually.

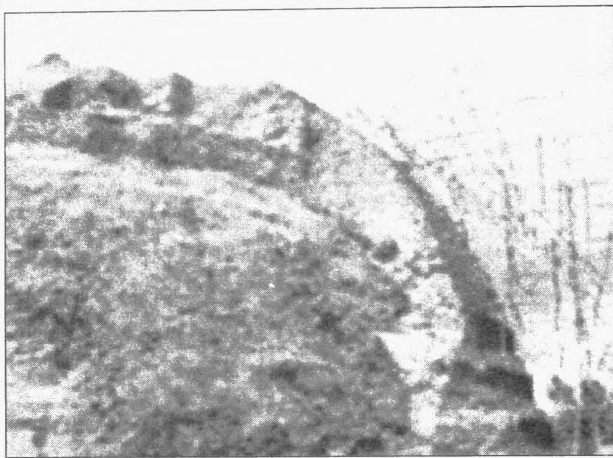
*Sandagiri Seya after the recent collapse of the added segment in restoration works*

Sandagiri stupa experienced a catastrophic failure recently with separation of large segments of new brickwork very similar to Mirisavetiya failure. Re-conservation works has commenced. The reason for the failure appears to be the same as in the case of Mirisavetiya. The conservationists and engineers have finally decided to use the very same technology used by the original builders, for reconstruction of the dome, namely, the use of "Butter clay" as a binder with a lime mortar cover. This would perhaps fulfill all conditions laid down presently for conservation of ancient monuments.
