# Criteria to Assess Rock Quarry Slope Stability and Design in Landslide Vulnerable Areas of Sri Lanka: A Case Study at Thalathu Oya Rock Quarry

M. N. C. Samarawickrama, U. B. Amarasinghe and K. N. Bandara

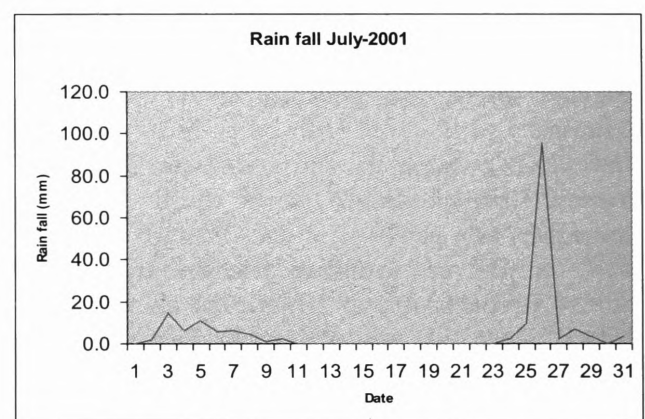
Figure 4 - Rainfall in July 2001 to ThalathuOya

The rainfall data for the particular area pertaining to the time of failure (i.e. July 2001) is plotted in Figure 4. As the rain fall graph depicts, area has received 95mm rapid precipitation on 26<sup>th</sup> July 2001. This may have caused the sudden increase of pore water pressure on the slip surface of the site, which

ultimately caused to initiate the failure as a debris flow on 28<sup>th</sup> July 2001 (according to the information given by the neighbors).

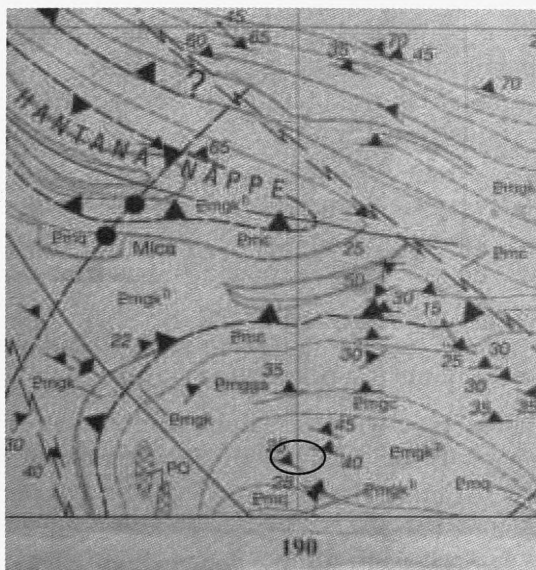
Figure 5 - Structural Geology of the area

When considering the site geological setting, the area belongs to the Highland Series of metamorphic rocks in the central part of the Sri Lanka. Furthermore the structural geology map of the area in Figure 5 reveals that, there is a shear zone running at the North-Eastern boundary of the site. This may be the initiation of the disturbance in the rock mass, which later act as the ground water seepage zone through the rock slope, along a weaker plane of foliation planes, which ultimately act as the slip surface. This can further be justified by the degree of weathering of the rock. The upper and lower parts of this seepage zone is weathered to a lesser degree than the seepage zone, whilst the mid slip surface is excessively weathered and the surface minerals leached due to this same ground water movement. Moreover, chert particles detected from mobilized debris as wells as thin crustal formations at the bottom of the right hand relief surface is good indication of groundwater movement for very longer period, where chert is formed by the

Structural Geology of the area reveals previous disturbances in this same area due to tectonic movements in adjacent shear zone. Hydrogeological pattern of the area has further worsened the situation by stagnation of water on this disturbed rock mass, may have caused to seep large quantities of flow through opened up more unstable joint sets down to more stable well developed weaker foliation plane, which finally became as the slip surface of the case under consideration. This fact has been further

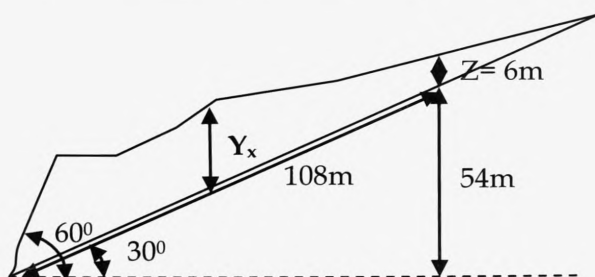
Figure 6 - Approximate Geometry of failed slope

Approximate geometrical parameters of failed slope were obtained from existing relief faces. The overburden thickness ( $Y_x$ ) varies from 4.50m to 6.50m. The location of probable tension crack was detected at the upper crest of the slope, where it can be traced from remaining extensions in the two relief wedges. The depth of the tension crack was around 6.00m.

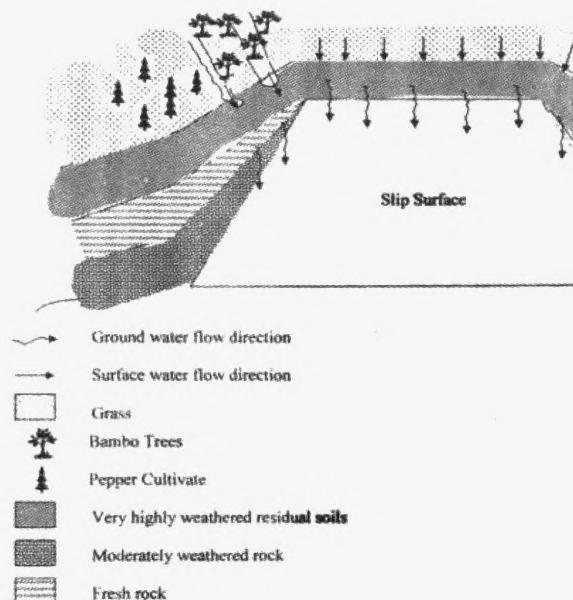
Figure 7 - Hydrogeological setting of the site

The ground water movement in the particular site is shown in Figure 7 and as it depicts, large volume of ground water as well as surface water is passed through the site in the rainy season. There is a catchment area of around fifteen acres which elevates to more than 40m from the crest of the slope. The existence of Bamboo trees in the upper and upper left side parts of the slope crest is a good indication to prove the shallow ground water existence throughout the year. Also existence of surface water draining canals pointing towards the site location is a good indication for water stagnation effect in the rainy season, which ultimately may have caused to increase the pore water pressure conveniently. As mentioned in section 3.3, this process was in existence for very longer period until the ultimate failure.

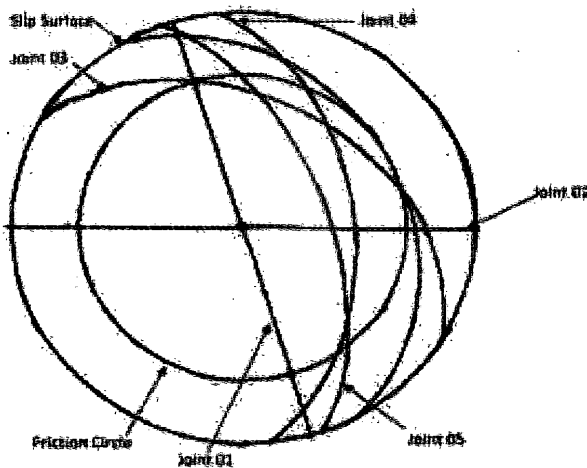
**Figure 8 - Stereonet plot of great circles of rock discontinuities**

The stereonet plot as shown in Figure 8 was developed based on data in Table 1 and the back analysis results of section 4.1, which was used to plot the friction circle. When considering the kinematic conditions of the possible rock slope failures, it is clear that vertical joint sets 1 and 2 may have contributed to form possible tension cracks due to toppling movements. Individual plane failures are possible for joints 2, 3, 4, 5 and slip surface. Out

of them, most vulnerable is joint 5 and least is along slip surface, which has the least dip. Wedge failures are possible along the combination of joint sets 2&4, 2&5, 3&4, 3&5 and 4&5. From kinematic point of view the most vulnerable of them is the wedging along the intersection of joints 2&5.

Stereonet analysis depicts that the failure type is combination of wedge and plane failures. Moreover, slip surface (which is parallel to foliation planes), which has the least possibility of contributing for the failure. However, initial micro level failures may have opened up these rock joints and later may have act as pipes of drains which brought surface runoff into an underlying weaker-well developed-foliation plane. It is evident that the failure has occurred along the presently exposed slip surface and hence the most contributory joint set out of above joint sets is a well-developed foliation plane and thus is a **plane type failure**.

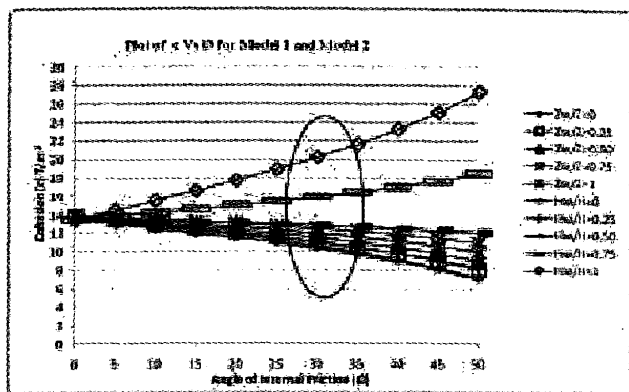
Figure 9 - Cohesion Vs Angle of Internal friction for both failure Models

Equations 1 and 7 in section 2.4.1 were rearranged by keeping the factor of safety (F) equals to unity (which is at limit equilibrium) and range of values were given to " $\phi$ " in order to obtain the variation of " $c$ " for two basic slope geometries, which depicts in Figure 9. Previous experimental studies have shown that " $\phi$ " for gneissic rocks is ranged between 27° and 34° [8]. This range is highlighted from the ellipse in Figure 9, from which, the mid value of the range for " $\phi$ ", which is 30° was taken as the angle of internal friction of the slip surface and the corresponding lowest possible value for " $c$ " from the curves become 10.35T/m<sup>2</sup> or 0.1035MPa.

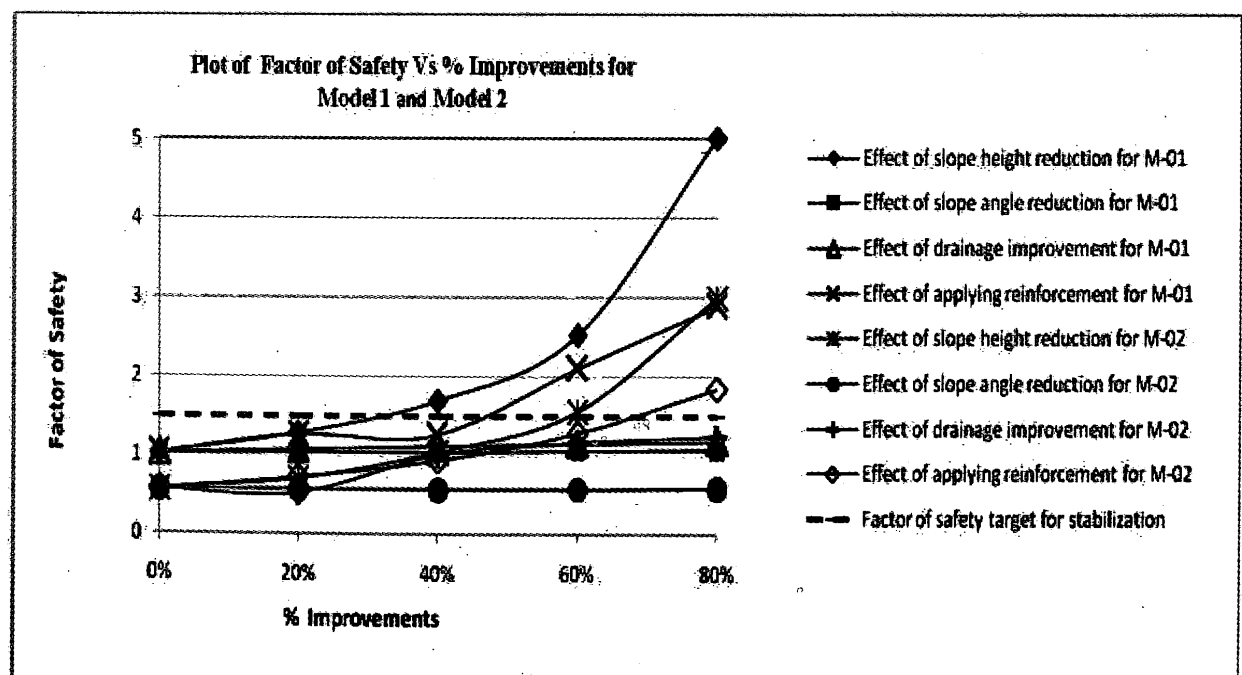
Figure 10 - Variation of Factor of Safety with Percentage improvement for both Failure Models

The required factor of safety was calculated by assuming the worst possible conditions, i.e. when the pore water pressure is at maximum for both of the assumed failure models (Model 01 and Model 02). The shear strength parameters deduced from back analysis were used in conjunction with Equation 1 and Equation 7 in calculating the respective safety factors and plotted the gained factor of safety against percentage improvement by the respective stabilizing technique. It is evident in Figure 10, that the required factor of safety, 1.5 (which is highlighted by the dotted line) can only achieved through reduction of slope height and the introduction of reinforcements. Out of these two, the most rapid (most economical) and practical method could be the reduction of slope height, as tension bolts will need to penetrate to greater depths than in normal circumstances, since the underlying bedrock is weathered down to a substantial depth. The reason behind lack of effectiveness in reduction of slope angle and drainage improvement can be explained through Figure 6, where slope geometry suggest that reduction slope angle will reduce the overburden weight in very low proportions as natural slope surface is running almost parallel to the slip surface after initial slope angle of 60°.

The same applies for drainage, where improvements in drainage is less effective compared to pore water pressure generated by large extent of slip plane having about 128m in length.
