# 1978 CYCLONE DAMAGE

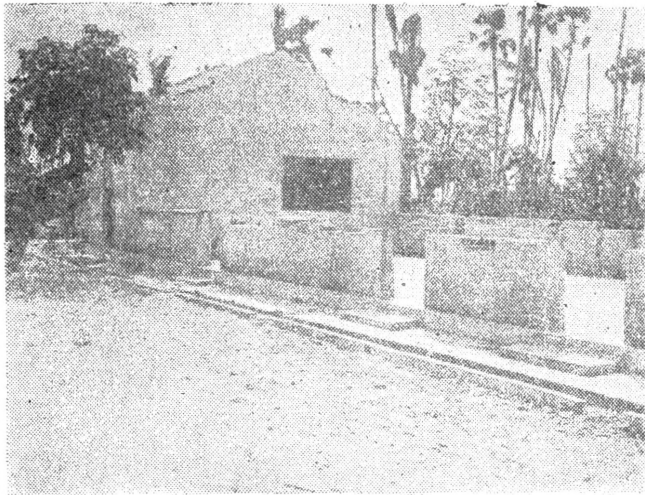
**Fig. 1. Classrooms**

## 1. Typical Failure of School Classroom Blocks. Fig. 1.

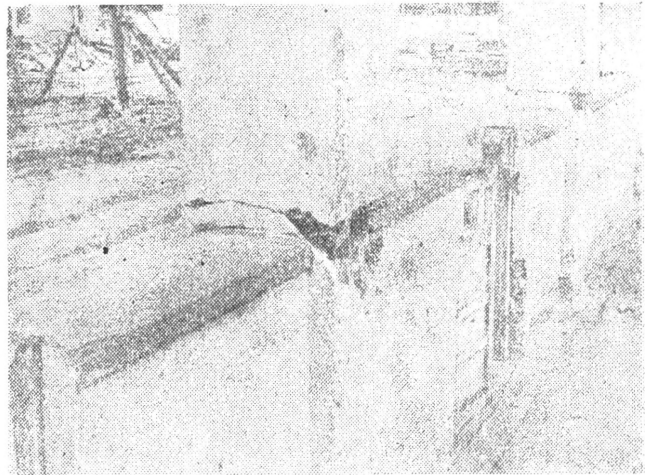
**Fig. 2. Shear failure of piers**

Brick piers failed in shear, but sometimes held in place by the well-anchored trusses. (Fig. 2)

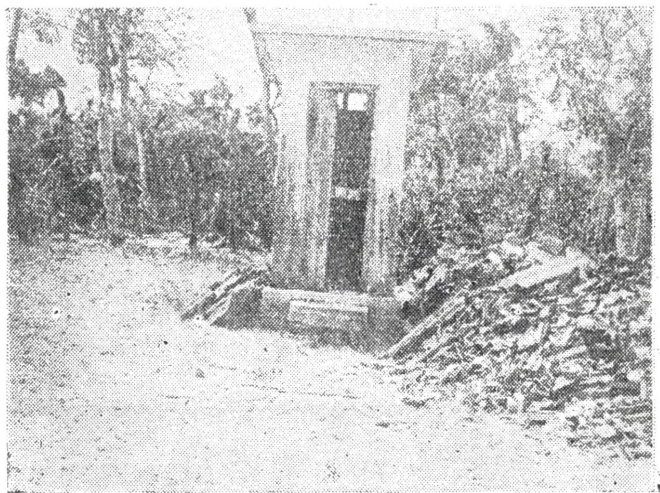
**Fig. 3. External toilet (undamaged)**

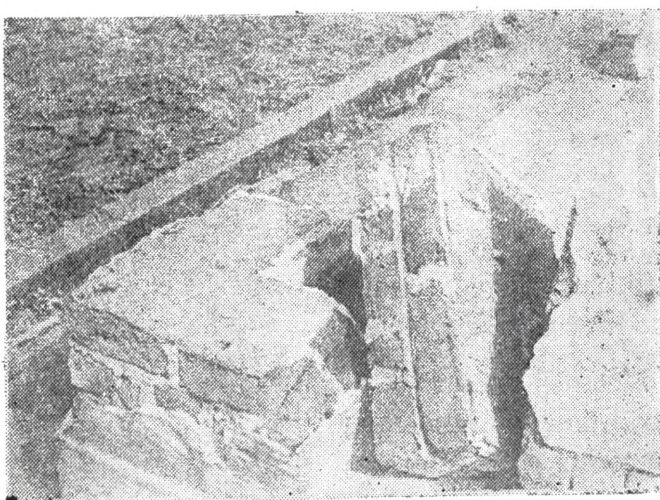
## 2. Evidence of bad workmanship in the cyclone damage.

**Fig. 4. Lack of bond in brickwork**

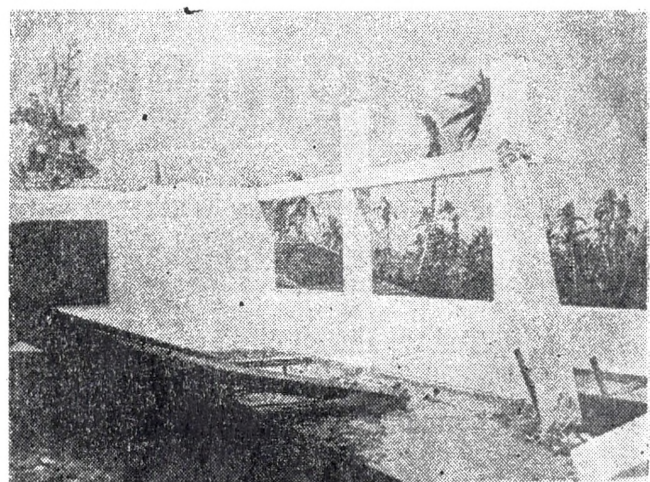
**Fig. 5. R.C. Column collapse**

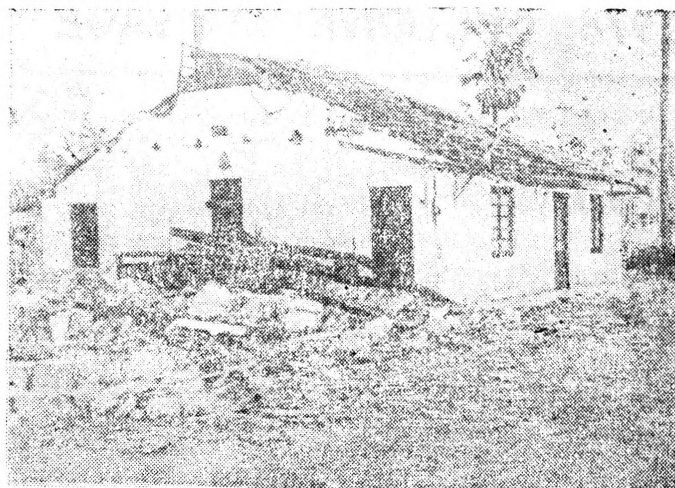
Fig. 6. Magistrates Court

Showing loss of roof tiles; collapse of open court room in front; relatively undamaged office rooms with cross-wall construction.

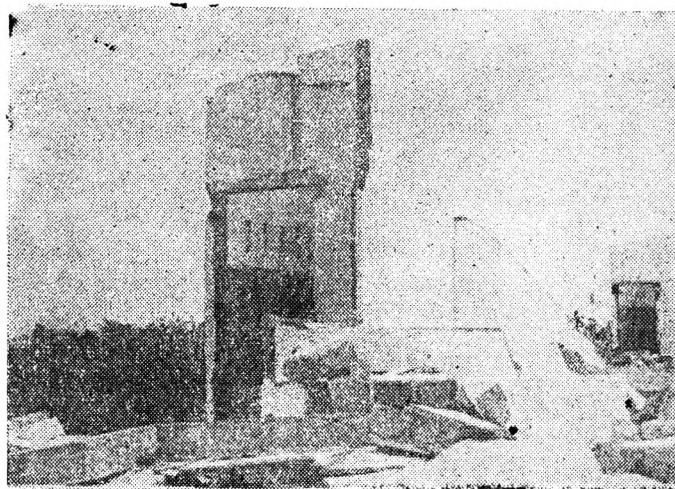
Fig. 7.

4. Collapse of low-cost housing, showing only the toilet blocks standing
