# Forensic Investigation on Design and Construction Failures

P. B. R. Dissanayake

**Keywords:** Failure, design, construction, investigation

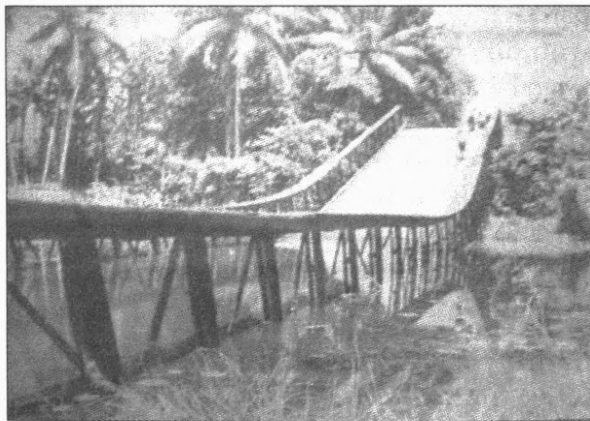
The bridge was originally constructed over Kala Oya in Anuradhapura in 1906 as a steel truss bridge and the then state of the bridge deck could not be found from available literature. In the 1965/66 period, it was removed from there and reconstructed in Paragastota by the Public Works Department. At this time, the bridge deck was covered with wooden planks. Subsequently, in the 1989-1990 period, on top of the timber deck, an in situ reinforced concrete deck was laid to a thickness of 150 mm. It appeared that in casting the RCC deck a substantial part of the timber planks of the old deck had been used as the formwork. The bridge was located in an area where a number of stone pits was present. It collapsed on the 10th July 1999 afternoon when a tipper, reported to have been carrying about 5 cubes of metal, was crossing the bridge. Failure state of the bridge is shown in Figure 1 below.

Figure 1: Failed bridge at Paragastota

To understand the failure of the bridge, a Finite Element Model of the bridge was prepared using SAP90 structural analysis software. Truss members were modelled as 3D frame elements. Furthermore, material parameters obtained from laboratory testings were put into the above model. From this structural analysis, it was found that the member force of the bottom chord member at mid-span is exceeding the elastic capacity when the 25 tonne tipper passes over the bridge. In other words, some members are likely to deform plastically when subjected to the above moving load. However, as the load is moving, the high tensile force is present over a small period of time, this preventing the progressive collapse of the structure in the first instance. Nevertheless, this will produce an irrecoverable deformation in the member. This is likely to cause a sag in the truss. With a the similar effect from the other members, forces are likely to change along with some other member forces also exceeding the elastic capacity. From the analysis it is evident that the failure was triggered by the yielding of the bottom chord members, resulting in large deformation, with consequent yielding and fracture of diagonal members [4]. Table 1 shows the summary of the findings.

were and thus the failure attributes from heavy loading on the bridge.

If the bridge was analysed before altering the timber deck to a concrete deck, this tensile stress increase could have been noticed and necessary alterations could have been done. Analysing all bridges in the national road network is not required. Indeed, such a methodology would be costly. However, there are needs to analysis bridges, which seem to carry heavy loads to avoid failures like in the Paragastota bridge.

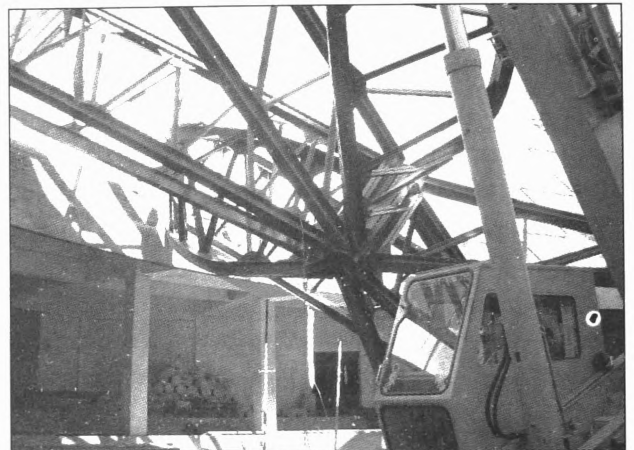
made at the centre to the hub. Afterwards, in order to make the end support connection (to the column), the crane operator had released the belts. While this was being done the belt nearer to the centre had snapped and the collapse occurred, while the outer end of the TR5-2 truss was still in the air, held by the crane.

Figure 6. Collapsed truss system

Investigation into the failure revealed that the Consultant had not given clear instructions to the Contractor regarding the construction procedures, even though the Consultant knew that the Contractor lacked relevant experience. Finite element analysis of the truss system (Figure 6) showed that the truss sub-systems used during the construction phase were not stable, because they were not adequately supported against out of plane buckling. The wobbling of the trusses experienced during construction, and the final failure was due to this. If an experienced engineer was present at the site during construction, he/she would have noticed these. Even though the Consultant had visited the site many times during the roof construction, poor quality of the work had not been reported, and the work had been allowed to continue.

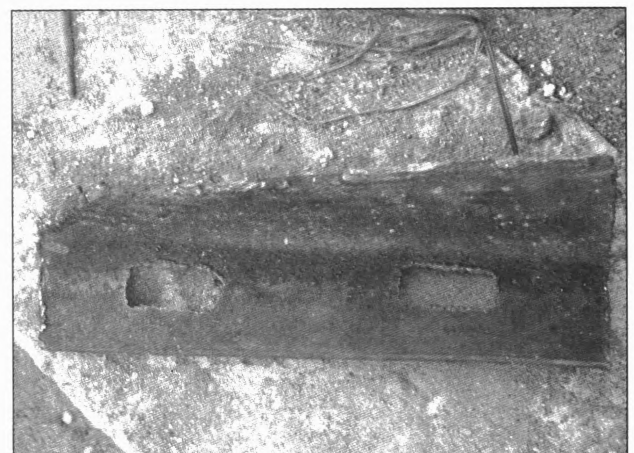
Figure 6 shows the collapsed truss system, and Figures 7 & 8 show some examples of very poor workmanship and violation of specifications, when making connections at supports.

Figure 7. Flame Cut Angle Bracket

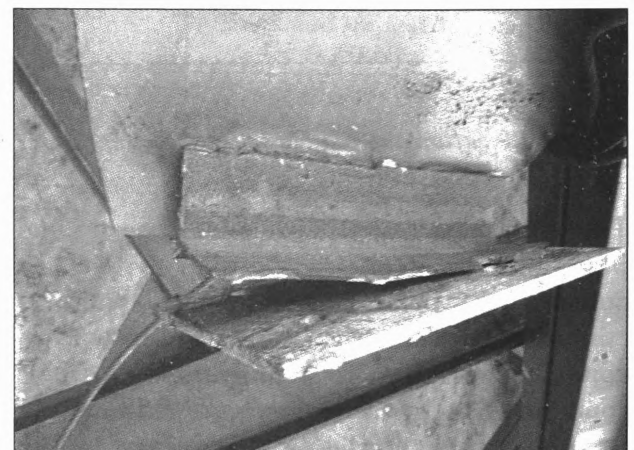
Figure 8. Poor Connection at Shoe Plate

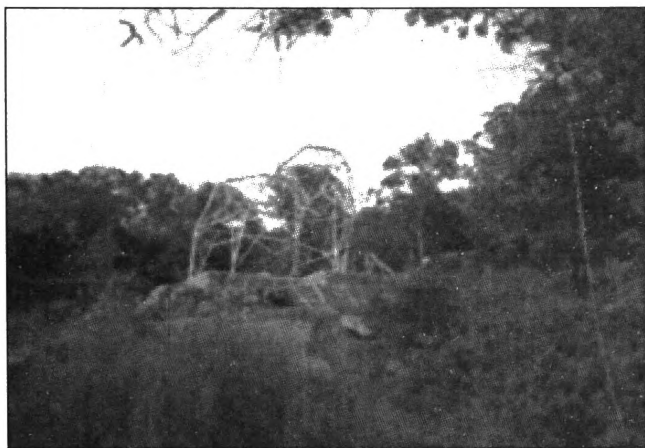
Figure 9: View of the collapsed stage of the tower

angle-iron type. The tower has been designed for steel antenna towers and antenna sporting structures. When it was constructed to a height of 60 m, the tower collapsed suddenly without any warning. Figure 9 shows the collapsed stage of the tower.

1. Compression and tensile forces in members are below the allowable limit of every section for the final design stage as well as for the collapsed stage.
2. At the construction stage, horizontal bracings have not been provided. However, the presence of horizontal bracings is very important since they reduce effective lengths of members and twisting also.
3. Local buckling check was carried out for the collapsed model.
4. All members are satisfied apart from some of the horizontal members.
5. In any connection, if bolts are not properly fixed, it will tend to transfer additional moments to the tower.
6. At the construction stage, the top part (final 10m) of the legs was erected as single angle. Furthermore, there are no bracings at the top part (final 5m). Therefore, the deflections are induced from there.

significant effect on the stability of the structure. In this situation, the Consultant supervised the construction work of the tower. Considering the results obtained, it can be concluded that the design of the tower is safe. With reference to notes 3, 4 and 5 mentioned above, the collapse of the tower occurred as a combination of local buckling behaviour at the construction stage and the conditions mentioned in note 4 and 5.

This failure could have been avoided if the proper construction procedure was given. As with ICTAD guidelines, it is the duty of the Consultant to see the sequences of the construction procedure. As with the general agreement of engineers, how sound a design is it will not be useful if the correct sequence of construction is not followed.

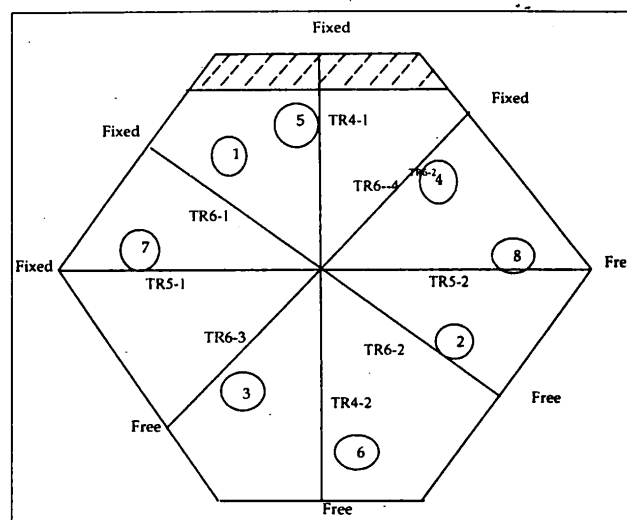
Figure A.1: T Roof Plan Showing Primary Trusses and Construction Sequence

The Steps a to d above were completed within 2 days and the four TR6 trusses were left standing for almost a month before the Steps e & f were completed (within 2 days). Two days after Steps f and g were attempted, the failure occurred.

When the first TR5 truss (TR5-1, one of the longer hip trusses), was put in place, wobbling had been very noticeable. Later, the second TR5 truss (TR5-2) was hoisted with the crane, using two belts attached to the truss, and two cables were used to tie the upper chord of the truss to the two main trusses on either side. After lifting the truss to position a connection had been
