REMEDIAL WORKS TO 300,000 GAL.

WATER TANK AT BIYAGAMA

by
Dr. A.N.S. Kulasinghe, K.W. Upasena and
G.A.R. Ganepola

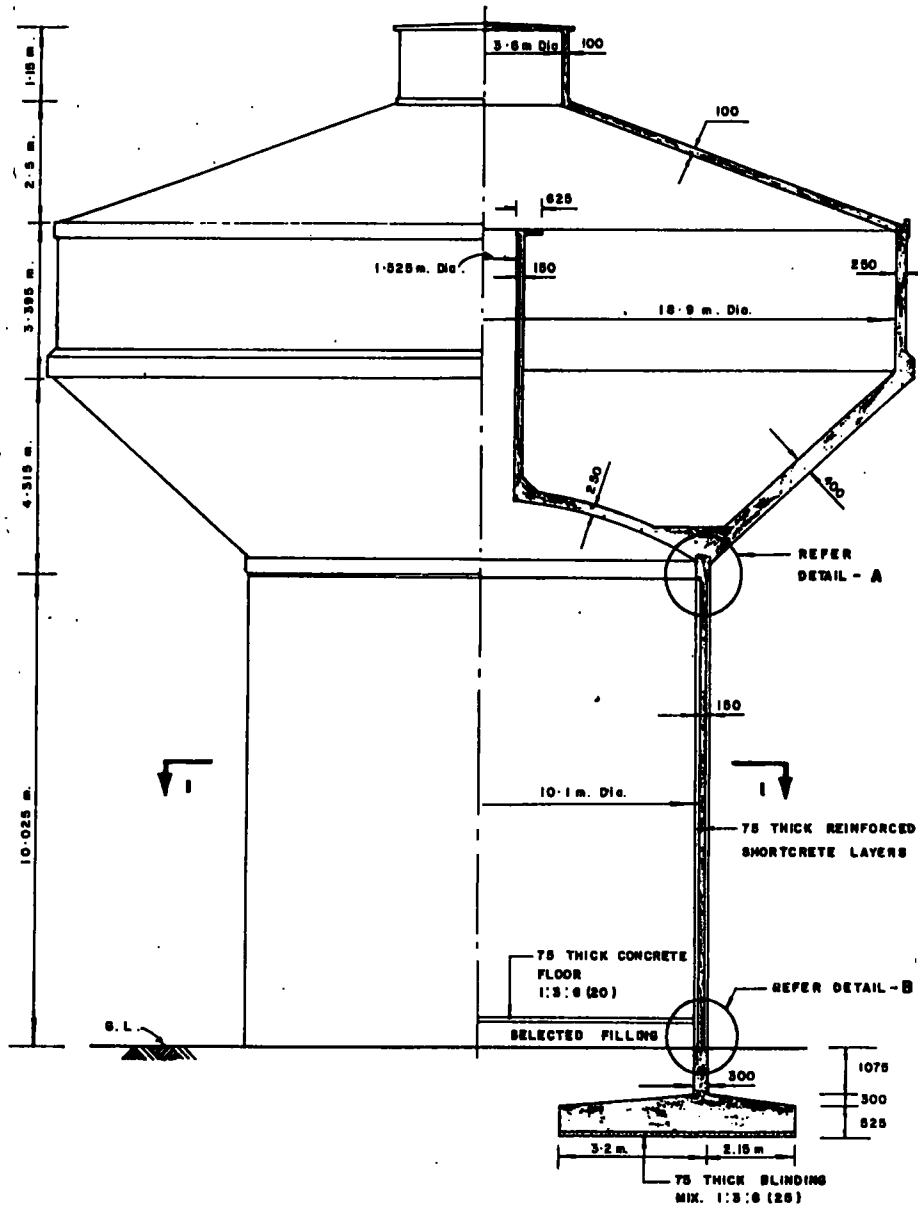
**Fig. 1. SECTIONAL ELEVATION
THROUGH VERTICAL CENTRE LINE OF THE TOWER**

The water tower consists of an Intze-type tank, supported by a cylindrical shaft as shown in Fig. 1. This shaft has a 150 mm thick, 10 m high cylindrical shaft of 10.1 m mean diameter. The reinforcement in the shaft consists of 10 mm Tor Steel bars at 225 mm centres both in the vertical and horizontal directions at the mid plane of the wall. Access stairs and pipes are accommodated within this shaft.

A crack of width approximately 1.0-1.5mm was observed at a height of 5 m from the ground extending horizontally round the shaft approximately from one end of a diameter to the other. It has been reported that during the slipform operation, the zone where the crack has appeared, the concrete was poorly compacted due to a power failure during construction. This crack has been stated to have
