A Comprehensive Study of Silicone Rubber Insulators with Different Creepage Distances

M.A.R.M. Fernando

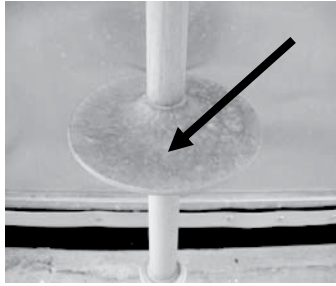
In KG site, as regards insulator appearance after the exposure, the upper sides of the insulator sheds became darker, while the under sides maintained their original color. Fig. 2 illustrates such discolouration on insulator #A. The top shed was always the darkest. It seems reasonable to believe that the darkening was caused by diffusion of dirt into the near surface layer of the insulator housing or by its encapsulation by the low molecular fraction of rubber polymer. The insulators from PG site showed similar discoloration as in KG site. The upper sides became darker compared to under sides and the top shed was the darkest.

Figure 2 - Discoloration of upper side of insulator #A

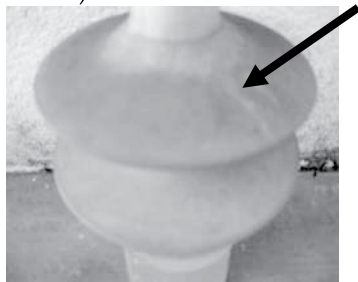
No significant surface changes (tracking, erosions, etc.) were found on the tested insulators. However, tree-like marks (only on the top shed) could be observed on insulator #I (hybrid insulator). This effect is shown in Fig. 4.

Figure 4 - Tree like discoloration on top shed of insulator #I

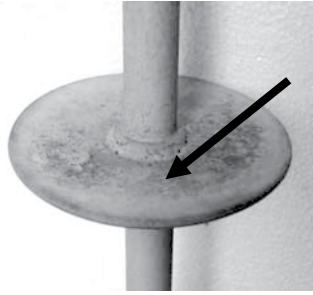
Fungal growth could be observed on the under side of the insulator. Fig. 6 shows such example. No fungal growths were found on other insulators.

Figure 6 - Fungal growth on underside of the insulator #A

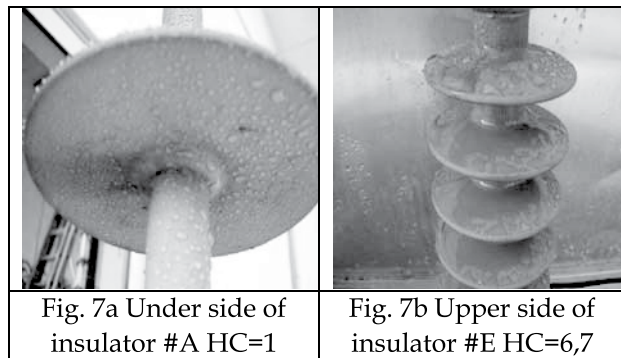
Figure 7 - Comparison of hydrophobic and hydrophilic insulator surfaces.

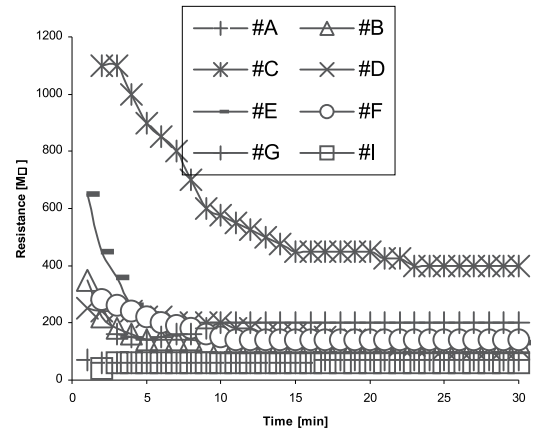
The time variation of the dc resistance of the tested insulators from KG site is shown in Fig. 8. The stable values of R and the ratios of dc resistance to the creepage distance (R/l) are indicated in the figure caption. In all cases the dc resistances were initially high and gradually became lower due to the fact that the insulators got wet inside the chamber with the time. Later these values stabilized. Among the insulators, insulator #C had the highest resistance of 400 M Ω , whereas insulator #I showed the lowest one of 60 M Ω . It could be observed that the insulators having a higher ratio of the shed diameter to the distance between sheds (#G-88/30, #F- 88/40, #D and #E- 80/35, #C -140/70 and #B - 140/100) showed higher dc resistance values per unit creepage distance. This higher ratio may therefore provide a better protection against deposition of contaminants on the insulator housing. However, insulator #I (shed diameter to distance between sheds - 130/40) was exceptional by having lower value of R/l , most probably due to the fact that the noticeable surface change (the tree-like marks) could influence the surface resistance.

When considering the values of dc resistance per unit creepage distance (R/l), some of the insulators (#B, #E, #F and #G) showed similar properties. Insulators #E and #G had almost similar R/l values but their hydrophobicities varied significantly. On the other hand insulators #C and #D showed similar hydrophobicity, but their R/l values were different. It should be noted that the correlation between hydrophobicity and dc resistance was not regular.

Figure 8. - Time variation of the dc resistance. R values in M Ω are 70 - #A, 130 - #B, 400 - #C, 110 - #D, 130 - #E, 140 - #F, 200 - #G and 60 -#I. The R/l values in M Ω/m are 189 - #A, 222 - #B, 701 - #C, 268 - #D, 238 - #E, 217 - #F, 240 - #G and 197 -#I
