# REMEDIAL MEASURES FOR SAMANALAWEWA LEAKAGE AND STABILITY OF THE RIGHT ABUTMENT BASED ON GEOLOGICAL AND HYDROGEOLOGICAL DATA

Vernon F. Pereira

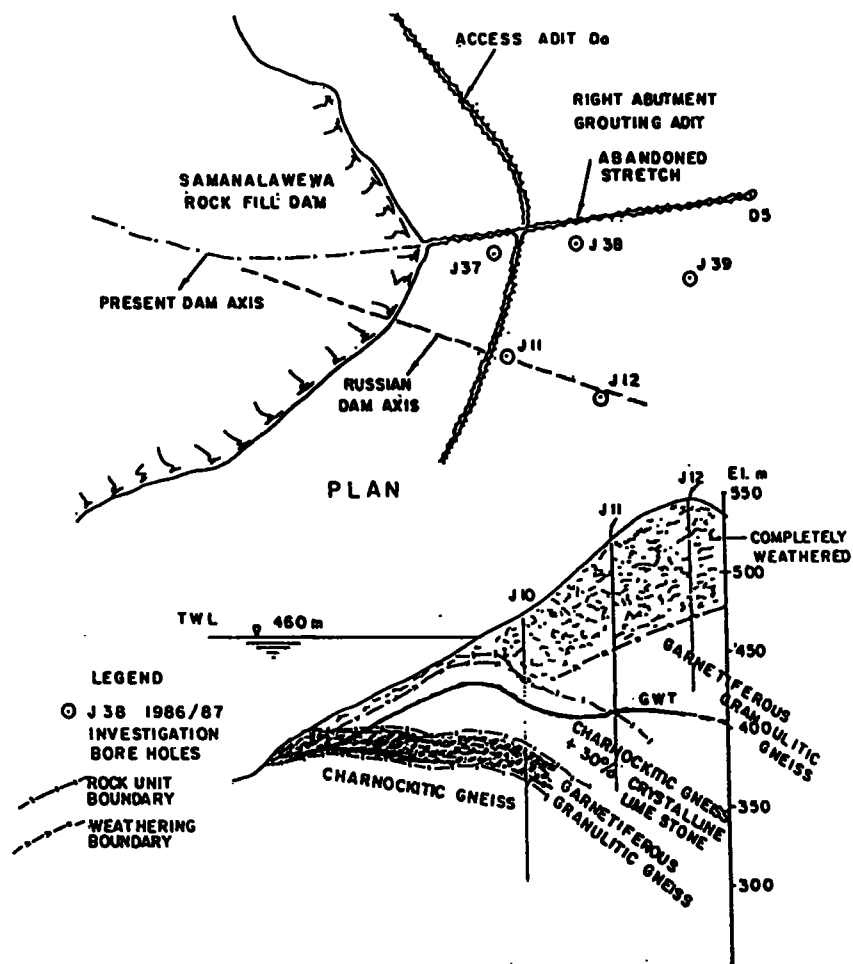
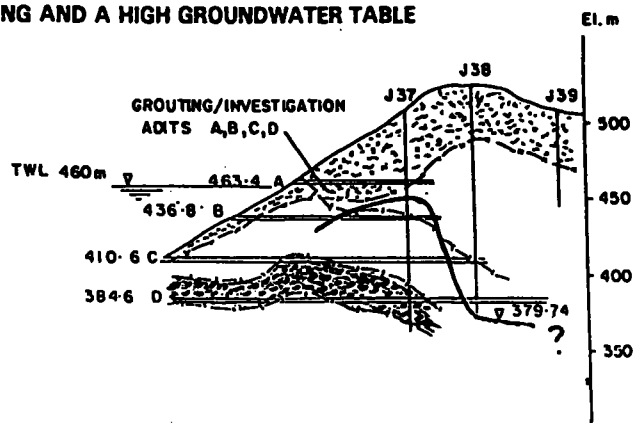
**Figure 1 - The Treatment of the Right Abutment Initial Proposal**

As a result of the 1986/87 additional geotechnical investigations, the original dam axis in the Russian proposal was partly diverted, curving it downstream on the right abutment. The bed rock on the right wing of the dam axis (Russian) proved to be intensively weathered to the level of El. 420 m, some 40 m lower than the contemplated level of the dam crest. Investigations at approximately 30 m downstream of the original dam axis (Russian) on the right abutment proved that the depth of intensive weathering was not so deep, the bottom of the weathering at elevation 445 m against elevation 420 m (see Fig. 1).

The unresolved uncertainties regarding water tightness of the right abutment were expected to be confronted by driving four grouting/investigation adits at different elevations into the right abutment along the dam axis (see Fig. 1).

**SECTION ALONG RUSSIAN DAM AXIS SHOWING DEEP WEATHERING AND A HIGH GROUNDWATER TABLE**

**SECTION ALONG MODIFIED DAM AXIS SHOWING SHALLOW WEATHERING AND A PLUNGING GROUNDWATER TABLE**

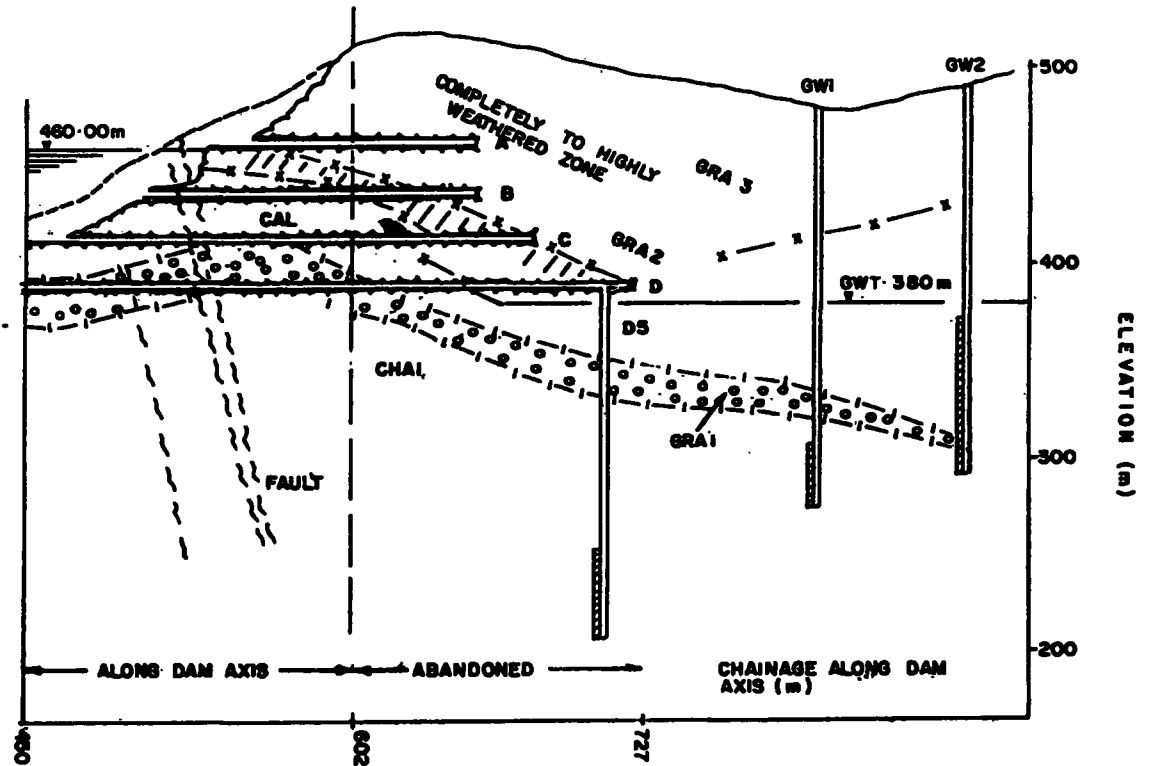
Figure 2 - The Deeply Weathered/Pervious Right Abutment

During construction, the excavation of the lower grouting adit 'D' revealed a fault zone and in adit 'C' a cave at E1. 410 m in the limestone containing rock unit. Exploratory holes were then drilled from the lowest adit 'D'. These holes indicated another 50 m of fractured rock. Piezometers installed showed a groundwater level at E1. 379 m. Permeabilities measured in these holes gave results of 5 - 80 lugeons. The design criteria used from the dam did not permit the grout curtain to terminate in the ground investigated by the 'D' series boreholes (see Fig. 2).

With the objective of assessing the geometry to tie the right abutment cut-off, deep boreholes were then done from the surface. These 200 m and more deep boreholes revealed continuing fractured rock and high permeabilities. It was only during construction in 1989, that piezometers installed in these boreholes revealed that there was a flat groundwater table at E1. 380 m on the right abutment/rightbank and that it was responding to river fluctuations (see Fig. 2).

- PIEZOMETERS INSTALLED IN 1989 DURING CONSTRUCTION REVEALED THAT THERE WAS A FLAT GROUND WATER TABLE AROUND EL. 380 m WHICH RESPONDED TO RIVER FLUCTUATIONS IN THE RIGHT ABUTMENT AND RIGHT BANK.
- 51% OF THE DRILLING AND 86% OF THE CEMENT FOR GROUTING OF THE DAM GROUT CURTAIN WAS DONE BETWEEN CHAINAGES 598 m AND 612 m.
- DAM GROUTING, TOTAL DRILLING 15,540 m, CEMENT TAKE TONS 70.9

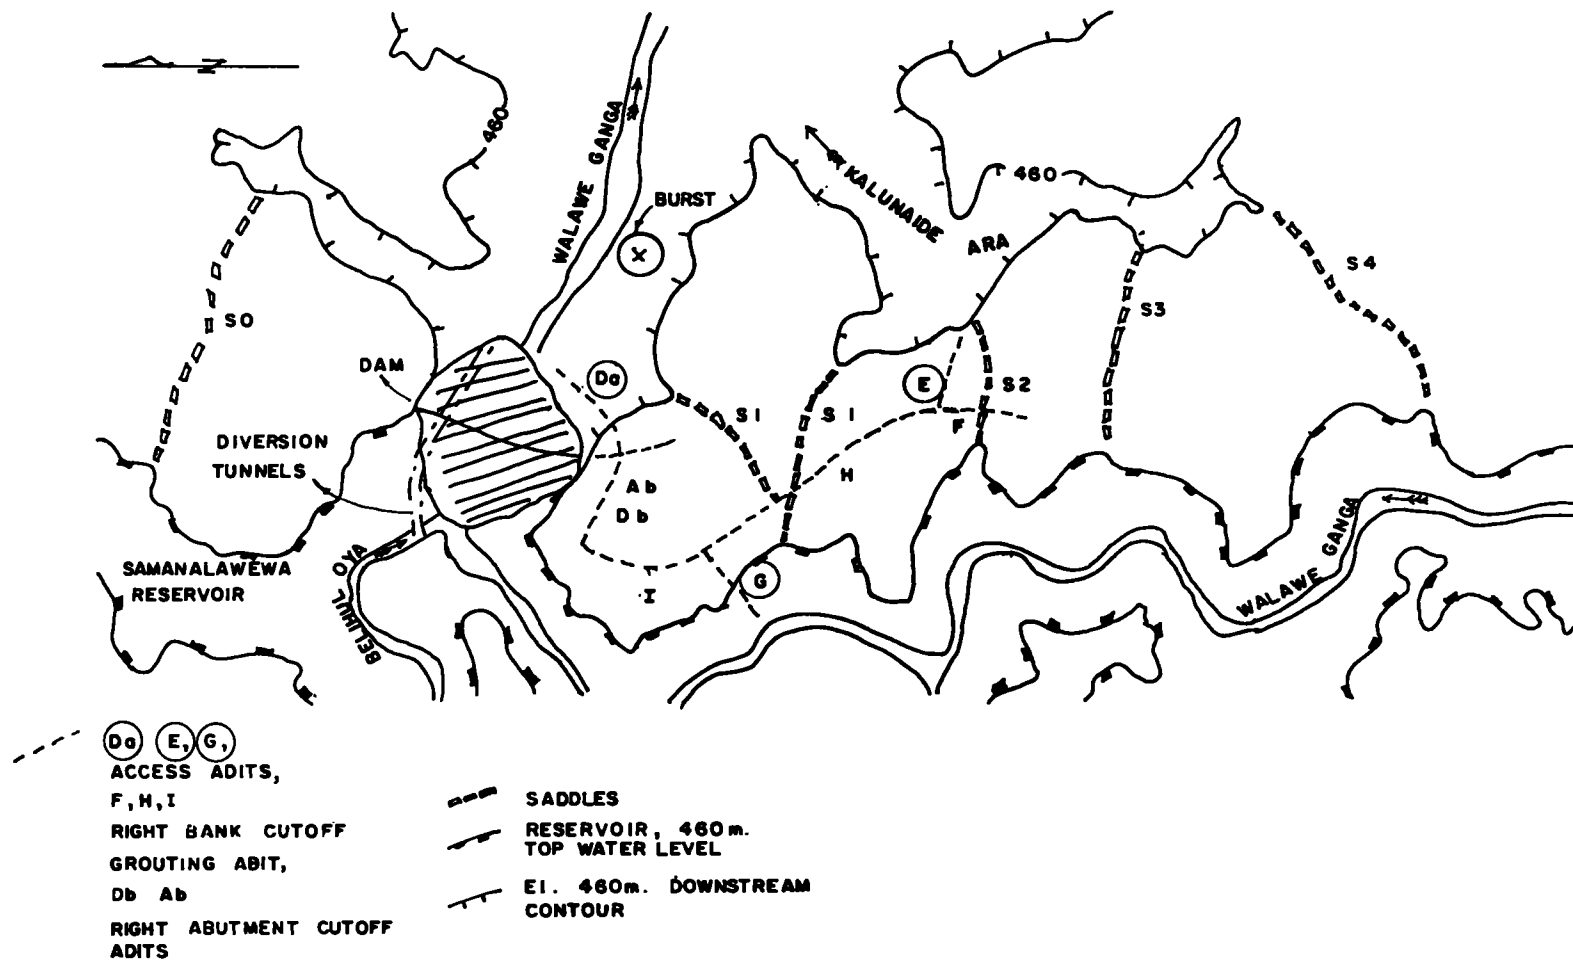
**Figure 3 - The Five Saddles**

The features identified were indicative of potential seepage paths at depth, within the right bank as suspected before tender. It was therefore clear as earlier proposed that further study and investigation works were required for the dam right abutment cut-off works and in the saddle areas for any cutoff design (see Fig. 3).

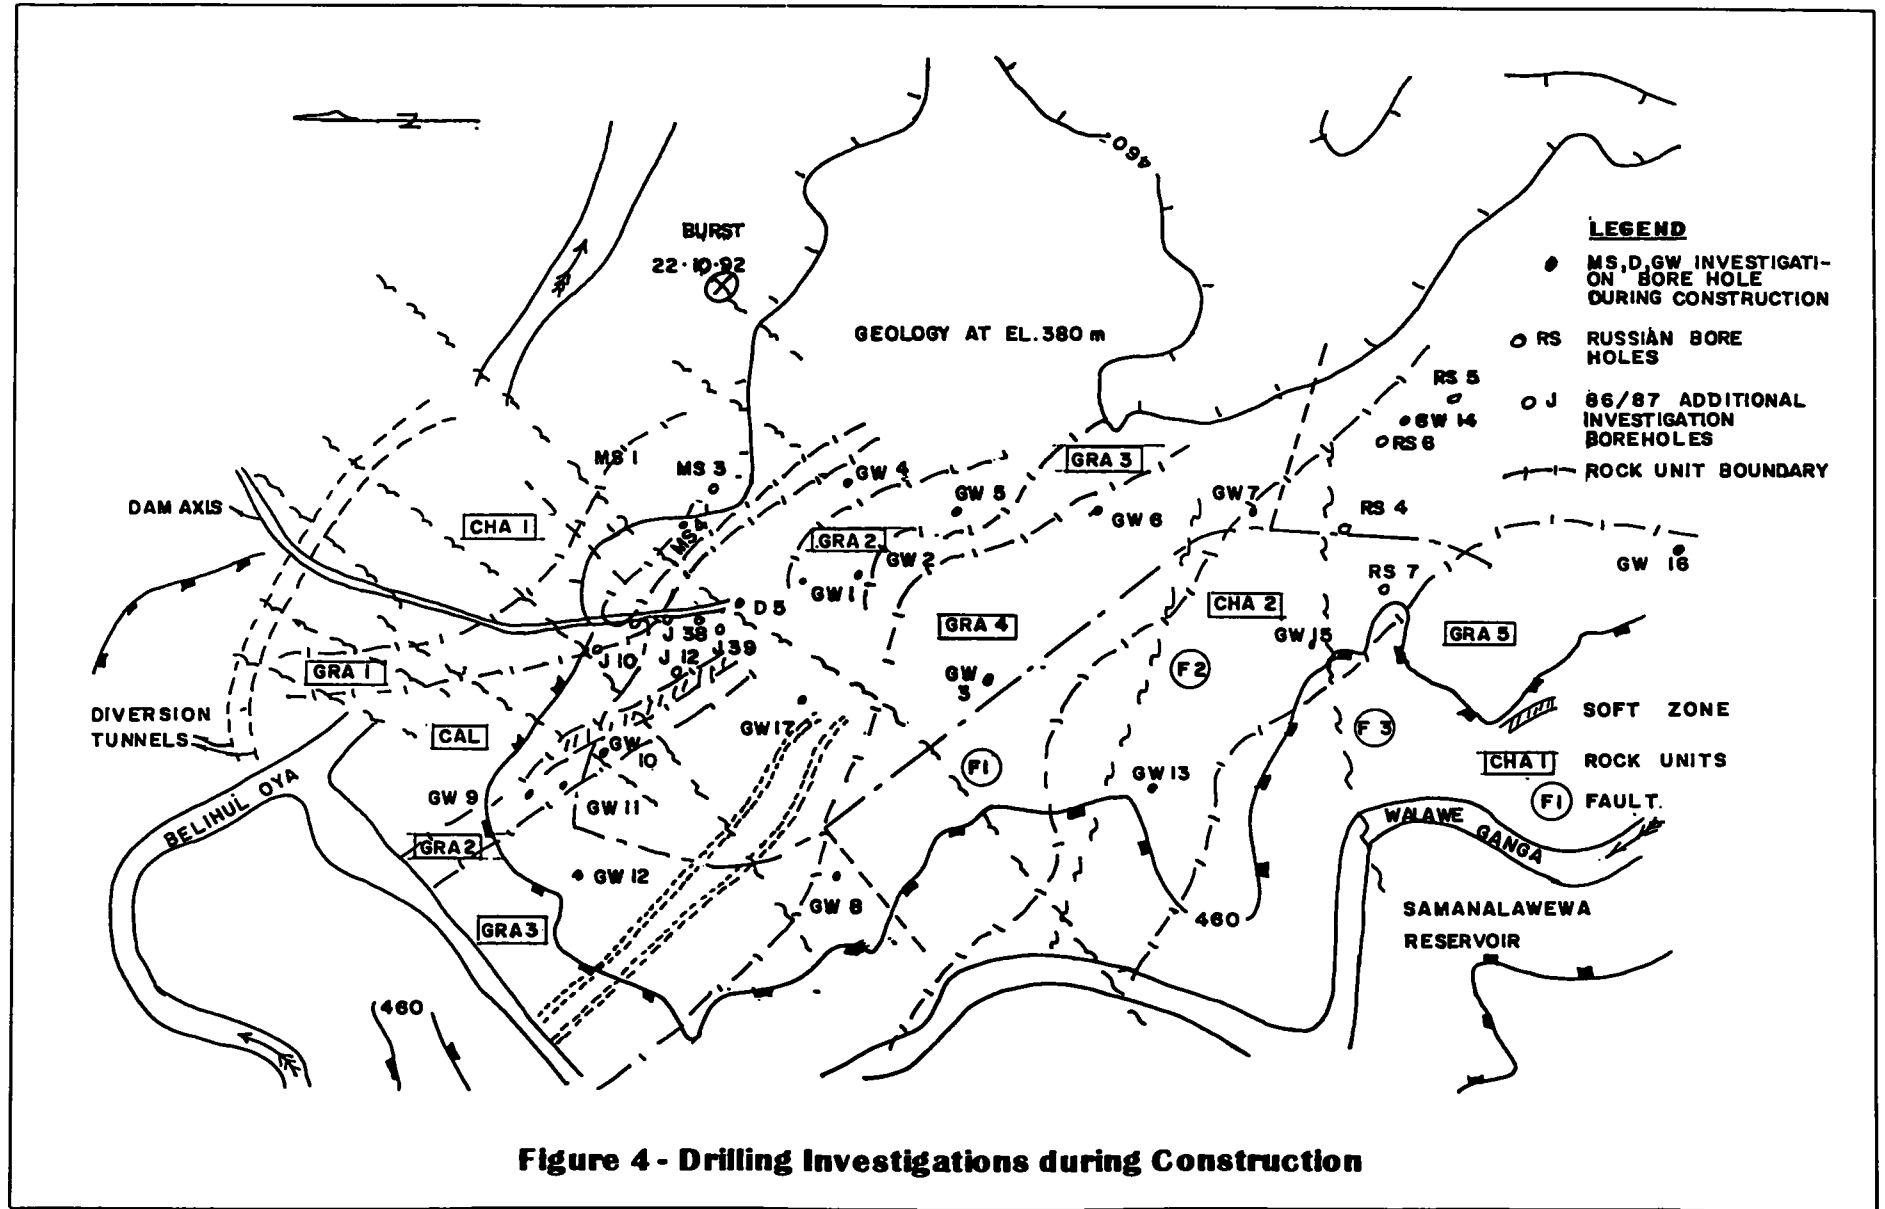
The soft cavitated layer between the limestone containing rock unit and the garnetiferous granulitic gneiss rock unit proved to be thinning out towards the upstream (see Fig. 6). Diverted adit A(b) was driven 100 m and adit D(b) was driven 300 m. One of the leakage paths designated as rout I was intersected by these adits (see Fig. 4).

Further, impounding the reservoir was abandoned considering it dangerous with the incomplete grout curtain on the right abutment and the right bank and also with the incomplete concrete lining of the 290 m long access adit E driven in completely to highly weathered rock (see Fig. 4).

the vulnerability of the dam right abutment as the deeply weathered, corroded 'area B' inter fingers into the dam body (see Fig. 4 & 6).

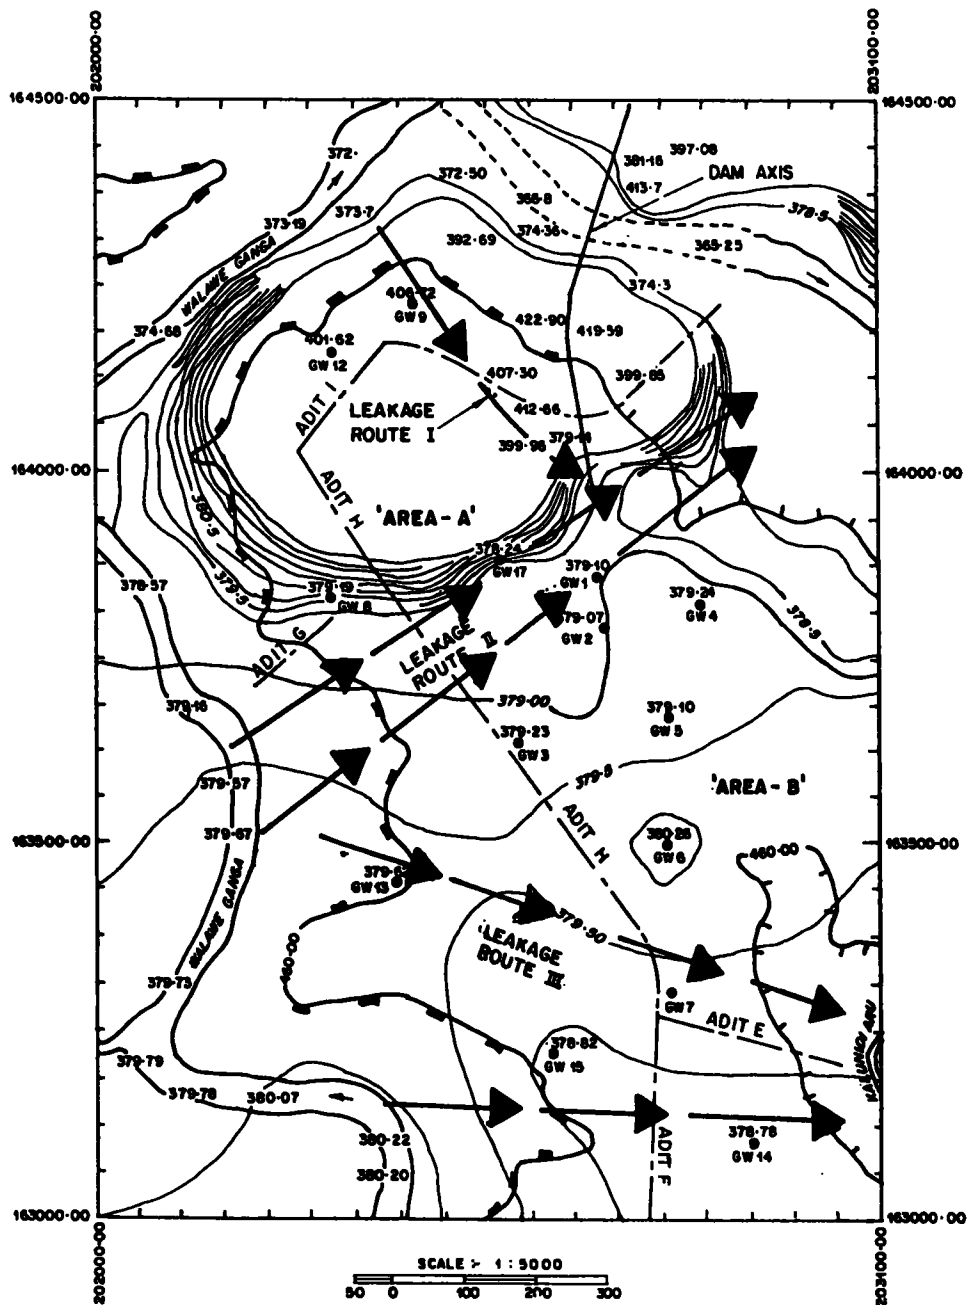
**Figure 5 - Groundwater Contours, Leakage Routes and Rightbank Cutoff**

Km from the dam on the rightbank where GW 18 was done (see Fig. 5).

The right abutment cutoff works designed to be done from the four adits A, B, C and D were abandoned beyond chainage 601 m abandoning 126 m of tunnelling in adit D the lower most. The top most adit A and the bottom most adit D was diverted almost through 90° upstream to tie up the dam grout curtain to an area where there was a high groundwater table at E1. 400 m - 410 m and good rock at depth (see Fig. 5).

Three major leakage routes were envisaged by the designer at the time of the rightbank cutoff design (see Fig. 5).

Leakage route 1, the leakage path through 'area A' which is along the inclined thrust fault running sub parallel to the strike of the rock, the soft zone.

Leakage route II running along the NNE-SSW, strike slip fault F1, which cuts across the strike of the rocks, which also more or less marks the boundary of 'area A' and 'area B'.

Leakage route III through Saddles 1 and 2 running along the strike of charnockitic rocks and the EW strike slip faults F2 and F3. The faults are sub parallel to the strike of the rocks in this area. (see Figs 5 and 7).

In 'area B', the calcite in the limestone has been removed by corrosion and alteration possibly by hydrothermal action. Corrosive features alterations and secondary deposits are prevalent in this area. The groundwater table is flat at E1. 380 m, at almost river level in this area (see Fig. 5).

As stated earlier, leakage route I was intersected by adits A(b) and D(b). Finally the right bank cutoff works was constructed from a continuous adit system with invert level close to E1. 390 m, starting for Saddle 2 aligned across leakage route III, across leakage route II and linking to the dam right abutment adit D(b) leakage route I area right abutment cutoff (see Fig. 5).

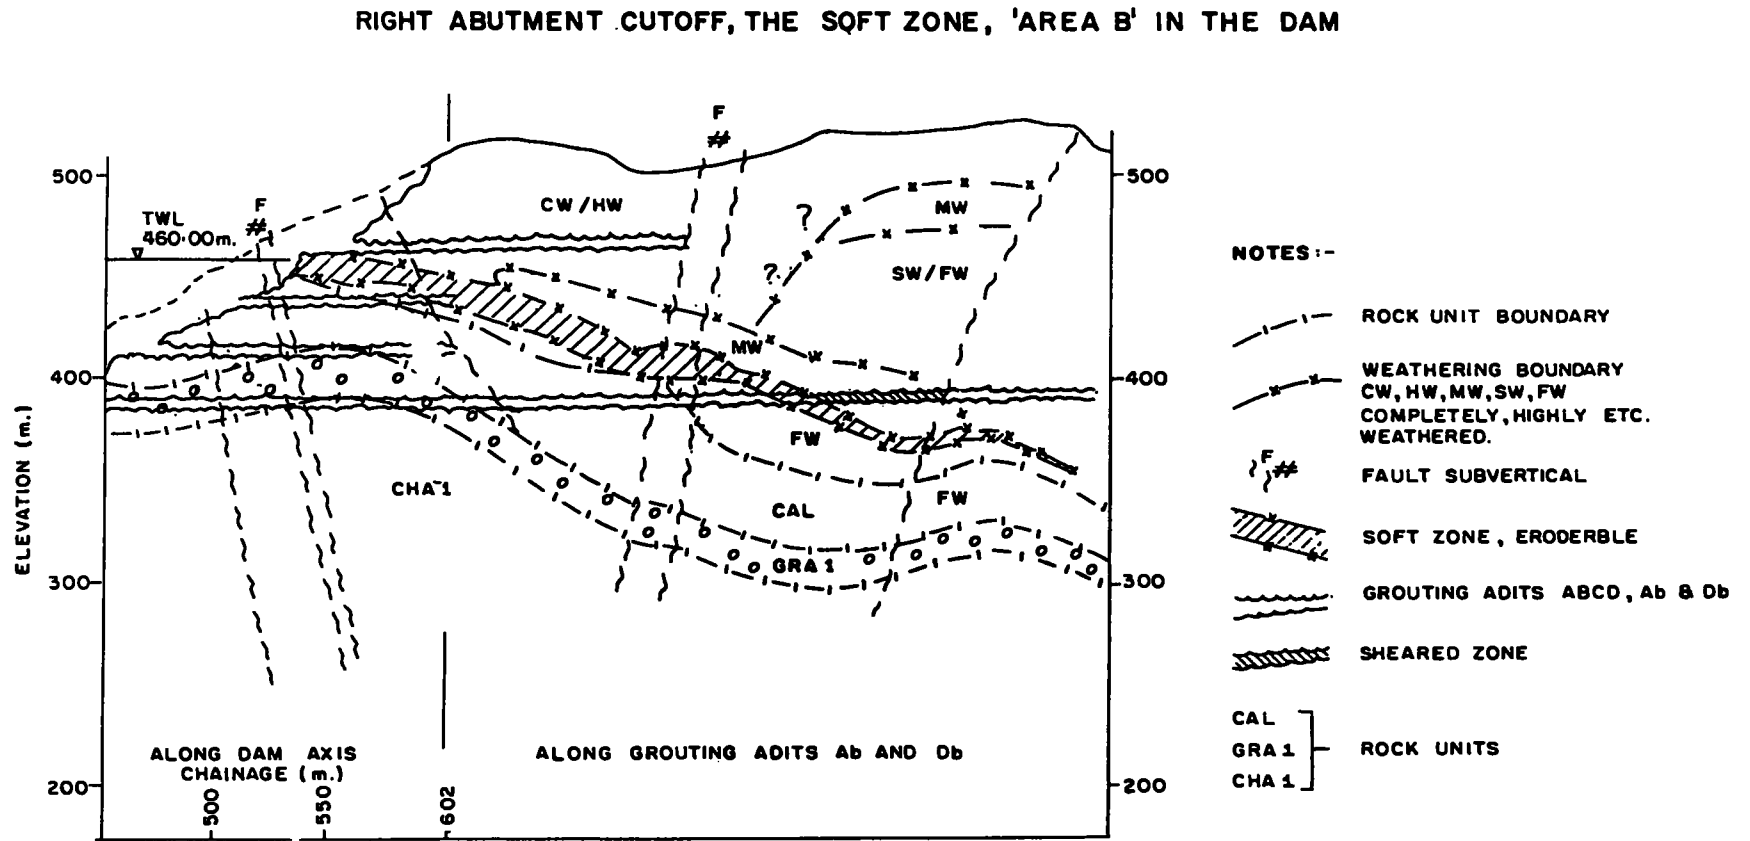
**Figure 6 - Geological Section Along Dam Axis and Right Abutment Grouting Adits Ab and Db**

The total drilling for grouting from adits A(b) and D(b) was 15,649 m. Altogether 1254 tons of dry cement was pumped into this area. The average grout take was 80 Kg/m (see Fig. 6).

However, it should be noted that between chainages 396 m to 612 m from right bank cutoff adits that most of the drilling and grouting was done in the dam. A total of 8018 m of drilling was done and 61.3 tons of cement was pumped into the soft, cavitated upper reaches of this area. Special grouting techniques such as jet grouting and high pressure grouting was done in the soft zone in the cutoff of the right abutment (see Fig. 6).

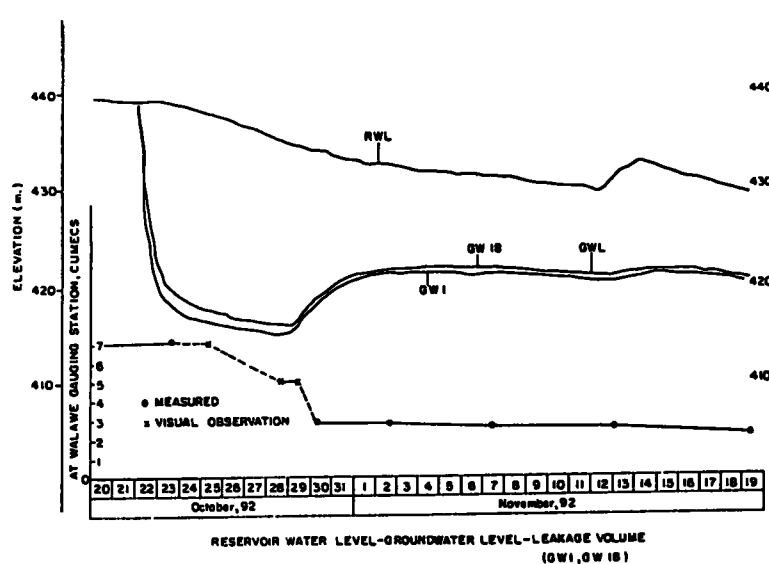
**Figure 8 - Reservoir Water Levels Vs. Groundwater Levels after the Burst**

With the burst all piezometers in area B dropped drastically to E1. 419-420m from E1. 438.43 within 24 hours. The discharge decreased to 5m<sup>3</sup>/s by the 28th and 29th of October while the groundwater level went down to E1. 415 - 416m. From the 29th October to the 31st October it was observed that when the discharge reduce from 5m<sup>3</sup>/s to 3m<sup>3</sup>/s that the groundwater level rose by 6 to 7m. This sudden rise in the groundwater table is attributed to a blockage of the leakage path caused by fallen rock or debris reducing the section controlling the flow. Such blockage of the leakage path could happen again increasing the rightbank pore water pressures.
