# USE OF REVERTIBLE BIO-POLYMER SLURRY TO RETROFIT A SAND CHIMNEY DRAIN AT HAYS CREEK DAM

This paper deals with some of the processes and details that were behind the philosophy to upgrade this zoned embankment dam. The thrust of this paper is with regard to the geotechnical aspects that were dealt in retrofitting a sand chimney drain using a revertible bio-polymer to facilitate construction in this dam. The first of its kind to be successfully completed in an operating dam in this country.

Hays Creek dam is a rolled earth embankment 27m high at the deepest section and has a crest length of 77m. It is located at the Hunua Gorge, south of Auckland in New Zealand (Map 1). It impounds approximately 1 million cubic meters of water at top water level. The dam and the associated filter station are currently owned and operated by Watercare Services Ltd (WSL) for the water supply of Papakura district.

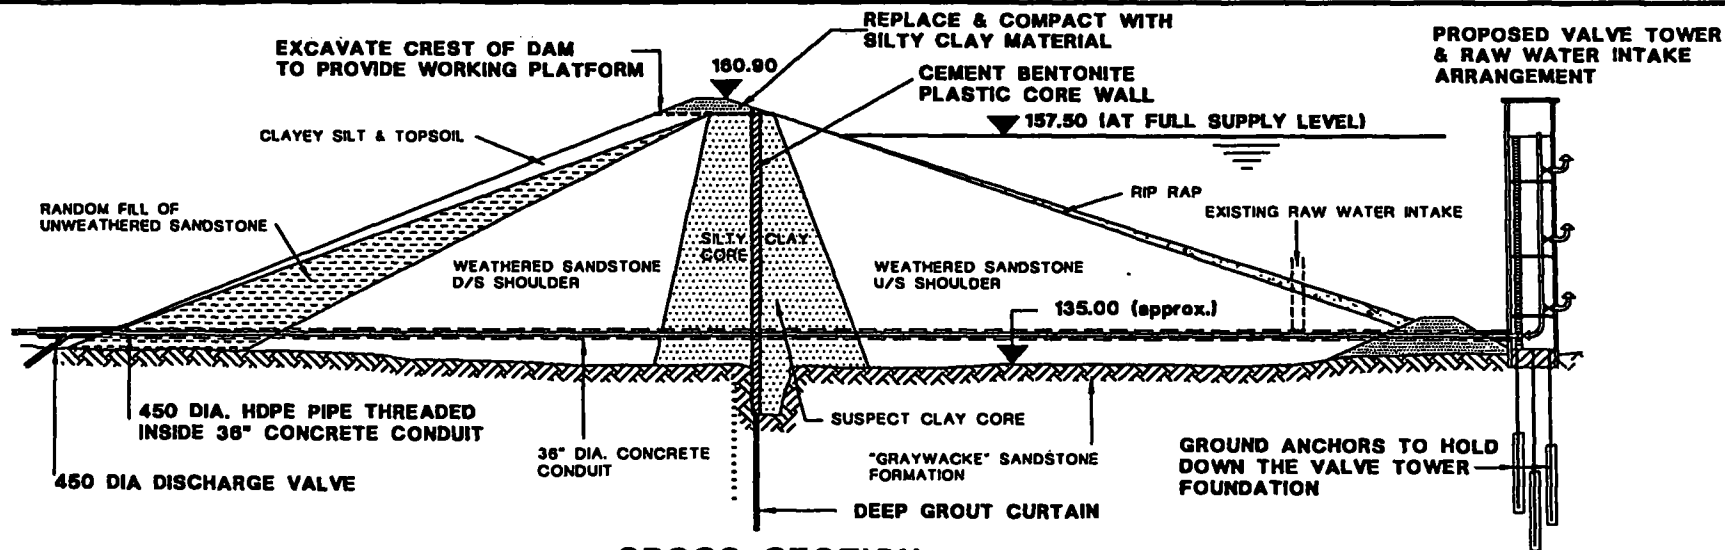
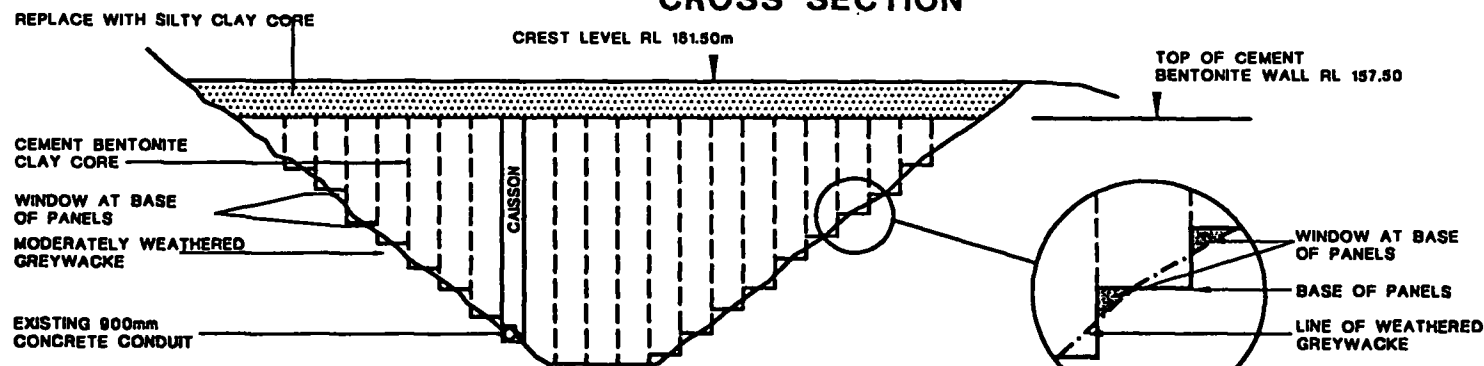
**FIG. 3**

- To excavate a trench through the existing silty CLAY core, from the crest of dam to the valley floor in bentonite slurry medium, and to replace the bentonite slurry with cement bentonite to form the plastic core (Fig 3).
- To provide a more reliable raw water intake arrangement such as a valve tower with all the control valves within a single dry well.
- To depressurise the 900mm concrete conduit and thread a 350mm HDPE pipe through the concrete conduit and to utilise the HDPE pipe as the raw water supply pipe line from the dam.

Expertise in the use of bentonite Cement Slurry walls is limited in New Zealand. For this reason WSL commissioned Gutteridge Haskins and Davey Pty Ltd (GHD) Australia as the external peer review consultant to WSL's in house design team. Following detailed studies, engineers from GHD concluded that keying the plastic core wall approximately 1m into the moderately weathered Greywacke sandstone might prove to be difficult. The consequence of such an ineffective key could lead to the creation of preferential drainage paths or 'windows' between the panels and the valley floor (Fig 3). The result could be an undesirable end product.

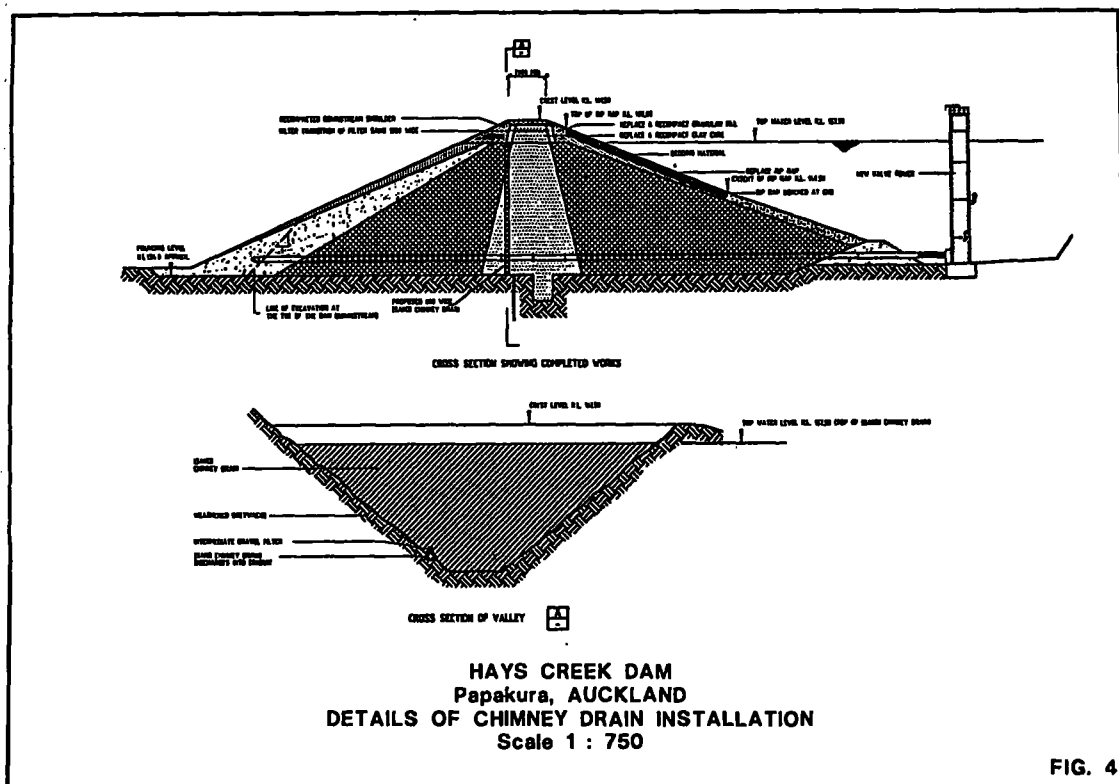
FIG. 4

concrete conduit. On reaching the required depth a 2m diameter steel caisson was lowered into the hole, and the slurry that remained in the caisson was pumped for storage and reuse. The location of the central drain and the detail of the connected works are shown in Fig 4. The contractor sank the caisson at exactly the intended location and no difficulties were experienced in carrying out this work.

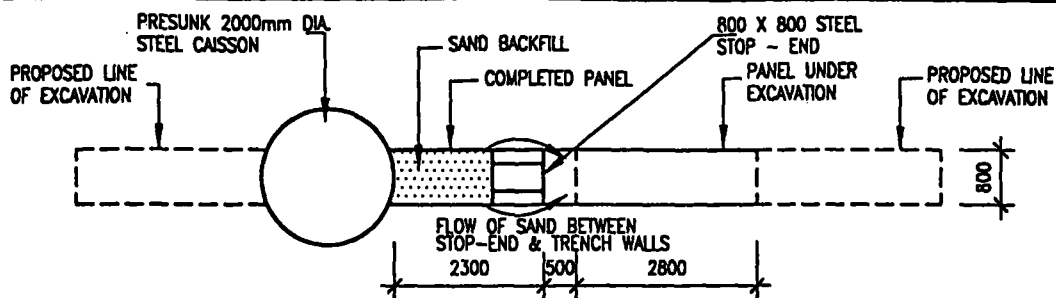
**Fig. 6A - Panel Installation with Steel stop - end**

The installation of the chimney drain began with a 2.8m long panel immediately east of the 2m caisson. The excavation of the panel was completed successfully and a 'stop-end' was placed 500mm from the end away from the caisson. The stop-end consisted of two identical I beams of 400 x 800 welded across the flange with a steel plate to provide a 'square box girder'. The stop-end was lowered into the trench with the

webs of the girder parallel to the trench wall. The stop-end was to prevent the flow of sand from the backfilled section into the unfilled 500mm space, so that construction of the adjacent panel could proceed with the sand retained in the completed panel. This arrangement was vital for the continuity of the sand drain.

However the trench walls were uneven because of the presence of granular fill and cobble to boulder sized particles in the silty CLAY core, and a tight seal between the stop-end and the wall of the trench proved impossible. When sand was placed in the 2.3m length of the trench some sand /slurry flowed around the stop end (Fig 6a). This was accentuated by the excavation of the adjoining panel (by the movement of the clam shell in the slurry). The excavation was abandoned when the flow of sand from one trench to the

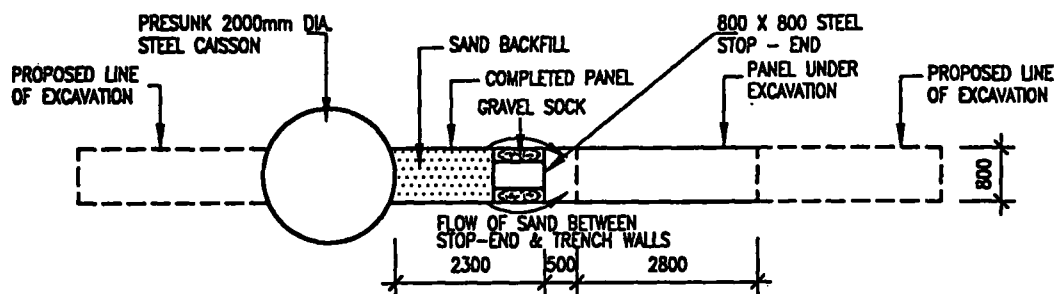
**Fig. 6B - Panel Installation with Steel/Gravel sock stop - end**

The stop-end was removed and the trenches were re-excavated as a single trench of 5.6m length to the foundation level of the dam. The stop-end was placed at a distance of 500mm from the furthest wall and the space between the web of the stop-end and the trench wall was packed with gravel filled geo-fabric sock. The contractor believed that the "gravel-sock" arrangement would control the flow of sand from one trench to the other during the construction procedure (Fig 6b). However this arrangement also failed. Sheet piling the space between the trench wall and the stop end was also tried (Fig 6c), but driving sheet piles through the sand proved unsuccessful and this alternative too was abandoned.

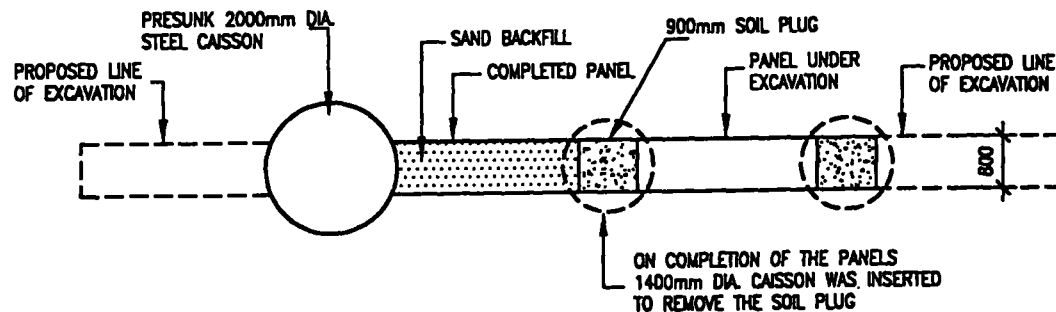
**Fig. 6D - Panel Installation with Soil Plug stop - end**

Yet another variation was tried out. Having gained confidence in working with panels of longer than 2.8m, WSL agreed to a longer panel length of 7.8m with a 900 mm "soil-plug" i.e. the existing soil left in place between excavated panels to act as stop-ends to separate these panels. In all five panels and five "soil-plugs" were created and the panels were successfully backfilled with sand (Fig 7). A caisson of 1400mm diameter was driven vertically with short rotational oscillations to completely encompass the 900mm soil-plug. While the caisson was advanced the soil-plug was excavated by a 'benoto grab' working inside the caisson. When the caisson reached the foundation levels it was backfilled with sand and withdrawn in stages.
