# RECOMMENDATIONS FOR INSULATOR-POLLUTION-FLASHOVERS IN SRI LANKA WITH SPECIAL EMPHASIS ON A STUDY OF COMPOSITE INSULATORS

M.A.R.M. Fernando, J.B. Ekanayake, A.C.S. Wijethilake, D.C.D.G. Wijeratna  
and S.M. Gubanski

## Abstract

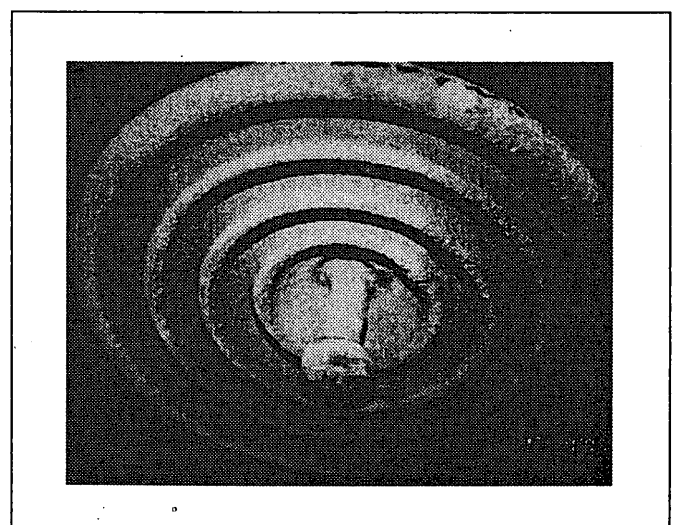
From the second period onwards, the deposition of cement dust was even thicker on all of the insulators. In general, higher content of dust was observed on insulators #1, #5 and #6. The dust was easily removable on SIR surfaces. Oppositely, hardly removable and partly solidified dust was observed on the other two (porcelain and EPDM) insulators. A contaminated porcelain cap & pin insulator is shown in Fig. 4.

**Fig. 4. Polluted porcelain insulator from the cement factory**

The main insulator problem in Sri Lanka due to industrial pollution is the cement dust. Thick cement dust deposits on any type of insulators independent of the insulating material and the dust is so thick that it is not significantly washed by natural rains. Thus this can only be eliminated by replacing the insulators. However, SIR surfaces, despite the thick cement layer, preserved the hydrophobicity (see Table 6). Good hydrophobicity reduces the risk of flashover incident by having lower surface leakage current. Thus SIR housings (insulators) or coatings (on porcelain) can be used for cement pollution.

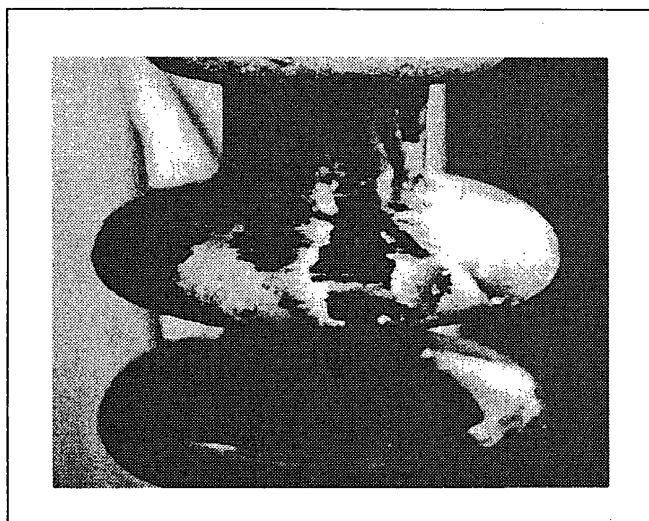
The porcelain insulator at the coastal site had been exposed to severe dry band arcing. These discharges were clearly visible at night during rainy seasons. These resulted in severe surface erosions on the insulators surfaces closer to the metal fittings. Part of the surface had burnt out. This effect is illustrated in Fig. 5.

**Fig. 5. Damaged porcelain insulator due to heavy dry band arcing at the coastal site**

porcelain insulators at locations with high concentration of salt pollution. Based on this extensive study and by taking into account the other relevant factors, it is recommended that silicone rubber composite and coated insulators be used to reduce the power outages due to insulator-pollution-flashovers in polluted areas in Sri Lanka.
