# Coastal Investigations for Sustainable Development of Fisheries Infrastructure

A. H. R. Ratnasooriya and S. P. Samarawickrama

**Keywords:** Coastal, Fisheries Infrastructure, Sustainable Development.

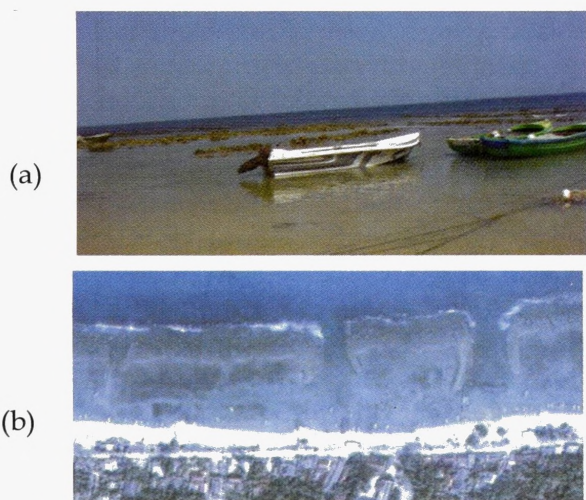
**Figure 8 - Northern Coastline: Point Pedro Area**

The coastline along the northern side of peninsula in Point Pedro is characterized by rocky/sandy beaches and a reef formation located close (< 300 m approximately from the coastline) and parallel to the coastline as shown in Figure 8.

Although the coastline, by its orientation, is potentially exposed to north-east monsoonal waves, protection against coastal erosion due to wave action is provided by the reef formation along most of the coastline. The presence of reef formation has also resulted in

a number of naturally sheltered basins in the area suitable for mooring of fishing craft.

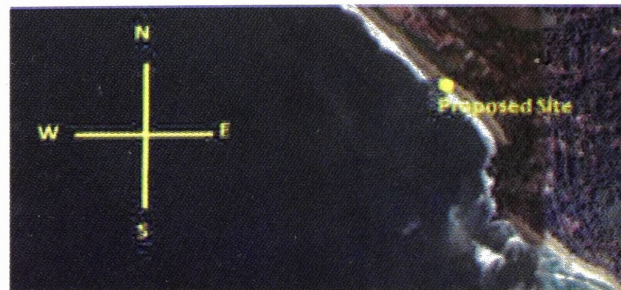
**Figure 11 - Proposed Site in Galbokka**  
(Source of Image: Google Earth Website)

The site is located in a wide sandy beach next to a rock outcrop as shown in Figure 11. From the rock outcrop, the beach extends uninterrupted for a few kilometres in the direction of Dodanduwa.

The investigation revealed a significant seasonal variation in the beach, in the order of up to 40 m in the vicinity of the project site, indicating high level of sediment activity. A beach profile with a steep gradient is formed at the site during the southwest monsoon, which, together with adverse wave conditions, makes it difficult for landing/mooring of fishing crafts. Due to the orientation of the beach at the site, as indicated in Figure 11, it is directly exposed to the south-west monsoonal waves and no sheltering effect is provided by the rock outcrop.

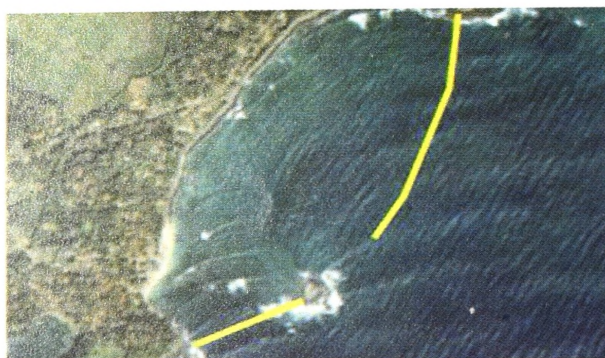
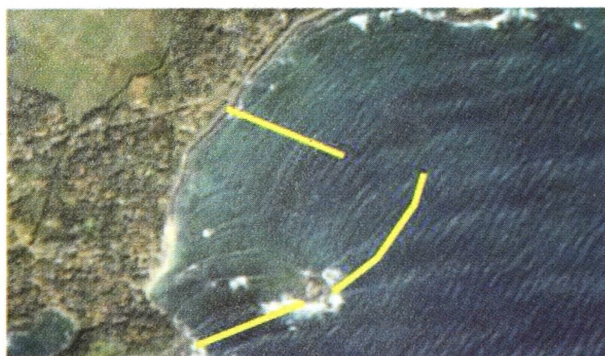
**Figure 14 - Development Options for Suduwella**

In the layout of the Option 1 (Figure 14 (a)), the entire bay area was incorporated into a harbor protected by two breakwaters. The entrance was placed between the large rock outcrop towards the southern end of the bay and the head of the northern breakwater to facilitate the fishing crafts to use the path followed earlier by the fishermen. It was subsequently revised to provide safer access conditions by

extending the southern breakwater beyond the rock outcrop.

In the layout of the Option 2 (Figure 14(b)), a harbor confined to the southern part of the bay, where fishery activities were concentrated, was conceptualized. The proposed harbor area is protected mainly by a southern breakwater which originates at the southern headland, connects with the rock outcrop and extends further in a northeasterly direction. The harbor entrance faces the northeasterly direction and is located in the gap between a secondary breakwater/groyne the main breakwater. Neither of these options had been implemented due various constraints associated with development. Investigations were thus conducted to identify a suitable development option within the constraints imposed to meet the stakeholder requirements. After extensive studies, in which attention was focused on coastal and harbor engineering, socio-economic and environmental issues, a conceptual layout, which is a modification of the Option 2 proposed earlier, was recommended for detailed design studies. It was to be implemented in two stages, if necessary in view of any financial constraints. The designs were subsequently carried out and a Fishery Harbor facility was constructed (first stage) which is currently in operation (Figure 15).

Studies had been carried out previously and two alternative layouts of development, one contained within the southern part of the bay and the other incorporating the entire bay, had been considered for further investigations.
