# Identification of Durability Problems in Earth Buildings

K. P. Arandara and C. Jayasinghe

**Keywords:** Earth walls, Durability

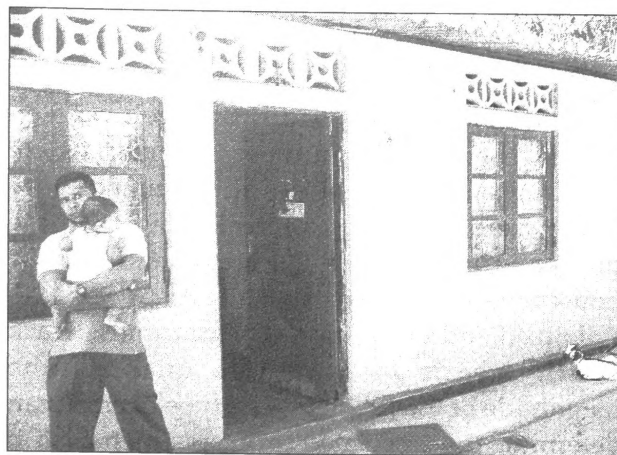
Houses inspected in Gampha (Biyagama-Ranavirugama), the walls are out of rammed earth. Some of the houses were rendered with a cement plaster and then paints were applied on it (Figure 1). Those houses are about 15 years old.

Figure 1: A rammed Earth house in Ranavirugama

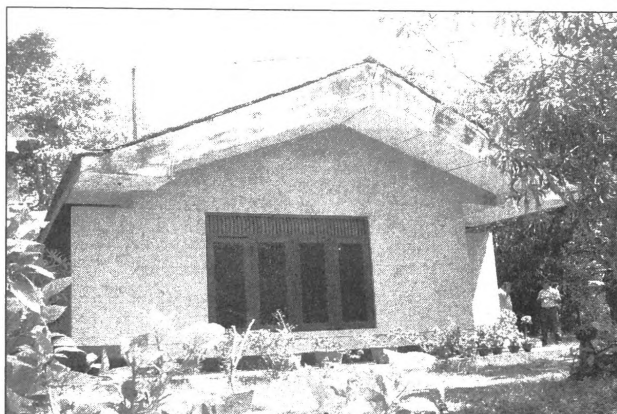
Houses inspected in Matara are 20 to 35 years old and most of those were constructed with stabilized soil blocks. These houses were painted directly without applying a plastering. Few houses were applied with a cement plaster (Figure 2) and normal paints applied on it.

Figure 2: A house made out of Cement Stabilized soil blocks in Matara

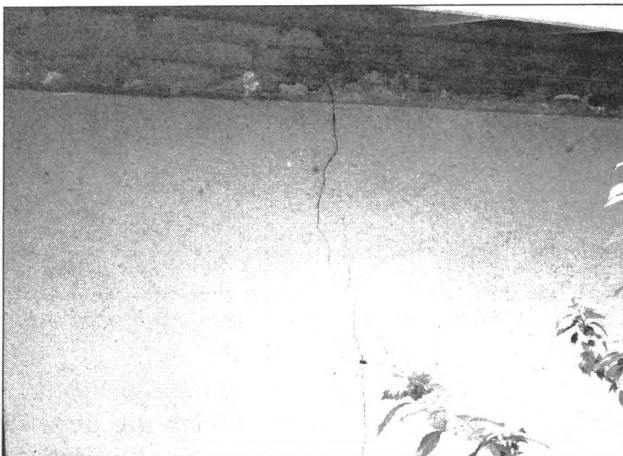
This is identified as a common problem in earth houses. Many houses had shrinkage cracks on wall plaster when two types of materials are involved such as soil blocks and rammed earth. There were fine thermal cracks found on the plaster in many cases. Figures 3 and 4 show houses with shrinkage cracks that appeared on stabilized and un-stabilized blocks walls. Crack width can be measured to quantify the magnitude of the problem. The type of crack can determine the associated problems such as; if it is a shrinkage crack, it is usually a through crack. In some instances it can be as wide as 2 to 3 mm. Plaster cracks are generally occur on the wall surface which are not through cracks. Plaster cracks are usually very fine in width.

Figure 3: Shrinkage cracks of the walls of a house made out of cement Stabilized Soil Blocks in Matara

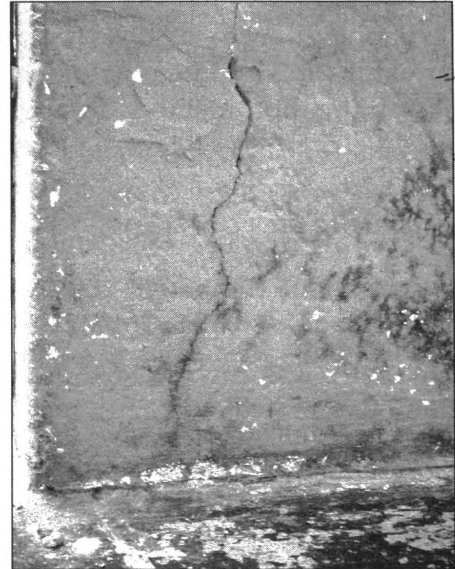
If the earth walls get saturated; wet strength of the wall will govern the stability. This situation has been identified in some of the houses and an example is shown in Figure 5. Such houses have less eave length and low plinth level.

Figure 5: A wetted wall made out of stabilized soil block

In order to quantify the acceptable level of wet strength; the earth building units must have at least  $0.4 \times$  dry strength [2]

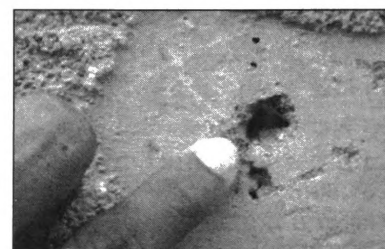
Some houses inspected during the filed survey were subjected to erosion due to driving rain. Figure 6 shows a picture of such a house. Most of the un-stabilized earth walls were subjected to this problem. If the wall is not plastered; the erosion can get aggravated. In case of this, erosion depth and eroded area could be measured so as to get a better view of behavior of walls due to driving rain. To measure the erosion depth, a flat ended rod of 10 mm diameter can be used since it has been specified for spray test which is described in section 6.1 of this paper.

Figure 6: A defect on an un-stabilized soil block wall of a house in Kosgama-Avissawella

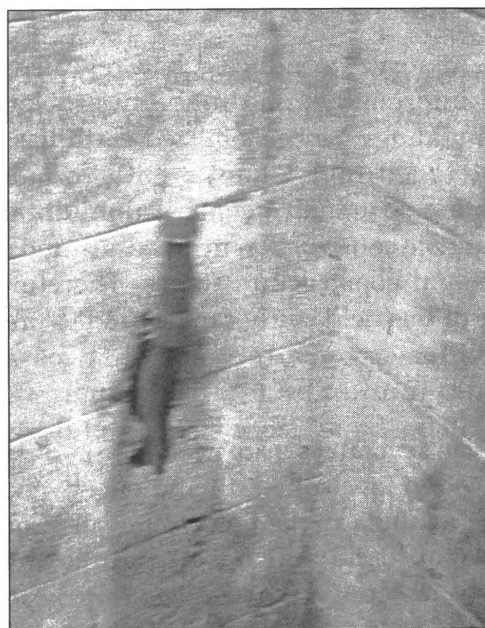
Figure 9: The problems with water lines

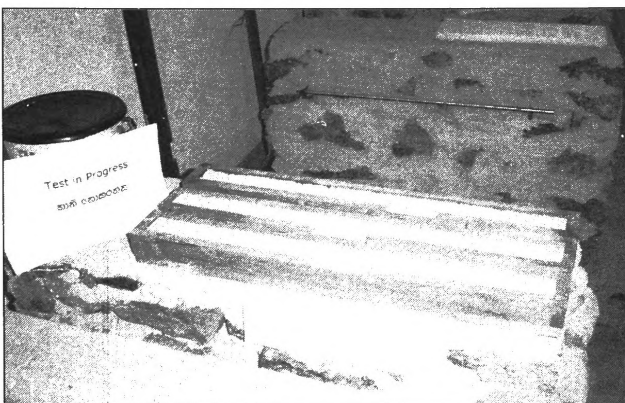
This test requires a timber or metal mould with internal dimensions of 40 mm (wide) x 40 mm (high) x 60 mm (long) as shown in Figure 12. First, the soil sample should be sieved with a 5mm sieve. Then 2.0 kg to 2.5 kg sample of the soil is mixed with sufficient water close to its optimum moisture content. Then, the mould is filled completely with firm wet soil; periodic tapping of the mould helps to remove trapped air. After levelling off the top total length the sample in the mould is sun dried for 7 to 14 days, until all shrinkage occurs. The total length of dried soil is measured to the nearest millimetre and then the percentage linear

Figure 12: Shrinkage test mould filled with soil

shrinkage is calculated. According to the percentages, the soil can be tested on the suitability for block manufacturing or rammed earth and as to whether the cement percentages are adequate for stabilization.
