Performance and Retrofitting of Unreinforced Masonry Buildings against Natural Disasters - A Review Study

W. S. W. Mendis, Sudhira De Silva and G. H. M. J. Subashi De Silva

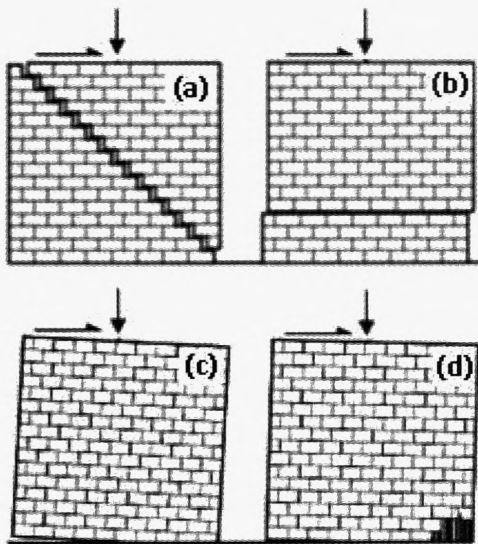
During earthquakes, the ground shakes in all directions and generates inertia forces that the structure should be able to withstand. Under seismic loading, URM walls have two main possible failure mechanisms: in-plane and out-of-plane (Saatcioglu *et al.* [32]). In-plane failures are characterized by a diagonal tensile crack pattern while out-of-plane failures are characterized by cracks that are primarily along the mortar bed joints. The principal in-plane failure mechanisms of URM walls subjected to earthquake actions are shear failure, sliding failure, rocking failure and toe crushing (Figure 1).

Figure 1- In-plane failure modes of a laterally loaded URM wall (ElGawady *et al.* [19]):
(a) Shear failure, (b) Sliding, (c) Rocking,
(d) Toe crushing

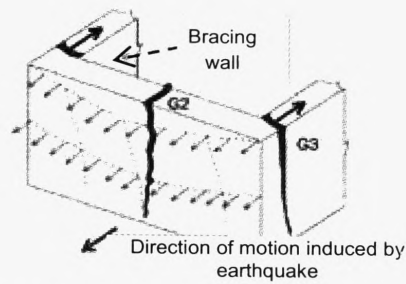
The typical out-of-plane failure patterns of URM wall resulted from an earthquake are shown in Figure 2.

Figure 2 - Typical crack patterns of URM buildings due to out-of-plane failure (Bartolome *et al.* [4])

the walls, where the tensile stresses are higher due to out-of-plane bending produced by seismic forces perpendicular to the walls (Figures 2 and 3). The continuity of ground movement produces large vertical corner cracks, which tend to separate the walls from one another (Figures 2 and 3). Shear forces generated by lateral seismic forces acting within the plane of the walls, produce diagonal cracks, which usually follow stepped patterns along the mortar joints (Figures 1 and 3). Due to the stress concentration at the corners of openings (i.e., doors and windows), diagonal cracks often start at these locations (Figure 3).

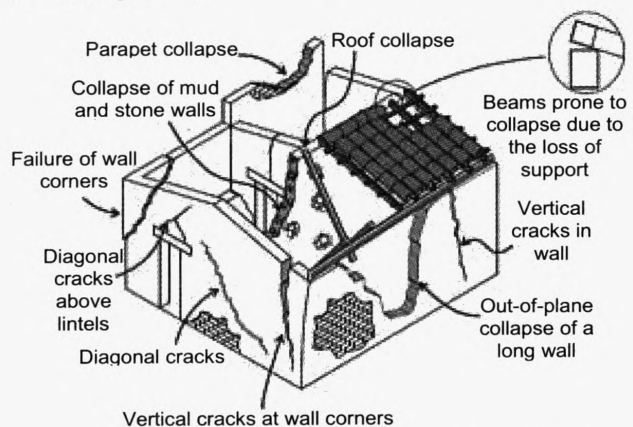
The traditional earthen buildings are vulnerable due to a perverse combination of the mechanical properties of their walls where earthen walls are dense and heavy, have extremely low tensile strength resulted from weak material, lack of reinforcement, poor workmanship and null maintenance (Bartolome *et al.* [5] and Blondet *et al.* [7]). Common failure modes of adobe structures were reported by Blondet *et al.* [6] (Figure 3). The same failure modes can be expected for other types of masonry buildings (Bartolome *et al.* [4] and [5], Blondet *et al.* [7], D'Ayala [11] and Kaplan *et al.* [20]) (Figure 4).

Figure 3 - Seismic deficiencies of adobe masonry (Blondet *et al.* [6])

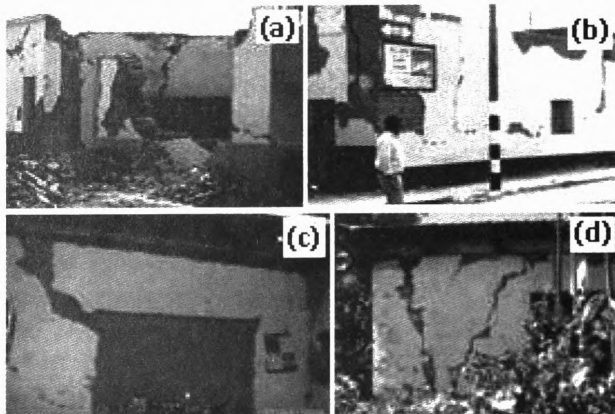
Front walls are, usually the first to collapse in an earthquake, overturning onto the adjacent street (Blondet *et al.* [7]) as shown in Figure 4(a) and (b).

Figure 4 - Seismic cracks in URM houses:

- (a) Collapse due to out-of-plane failure (severe earthquakes in Peru) (Bartolome *et al.* [4]),
- (b) Typical cracks on adobe houses due to out-of-plane seismic forces (Bartolome *et al.* [4]),
- (c) Shear cracks initiated at the corners of openings in wall of house in La Tinguña (in-plane failure) (Bartolome *et al.* [5]),
- (d) Wall-diagonal crack and vertical corner crack (both in-plane and out-of-plane failure) (Kaplan *et al.* [20])

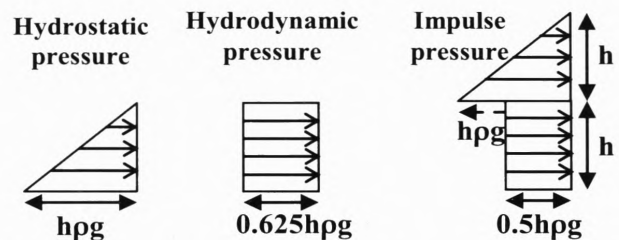
Damages of URM buildings by tsunami effects could be due to hydrostatic, hydrodynamic, impulsive, impact and buoyancy forces (Figure

5). Both static and dynamic loads are dependent on wave height as wave velocity is related to its height (Dias *et al.* [13]). Therefore depending on the wave height, damage level can be differed in various types of structures. It has been found that most single storied masonry structures completely pushed off their foundations in sliding mode, due to no tying down of structure and less self weight caused by thin wall (130 mm) of half brick (Dias *et al.* [13]). Renuka and Lewangamage [30] found that main failure types in URM structures were bending, diagonal tension and compression, overturning and sliding (Figure 6), by conducting a Finite Element Modeling (FEM) of single storied and two storied houses while Dias *et al.* [13] have also stated that overturning and sliding are two of main threats from tsunami wave on a structure.

Figure 5 - Components of tsunami induced forces, where h is inundation depth, ρ is density of water and g is gravitational acceleration (Renuka and Lewangamage [30])

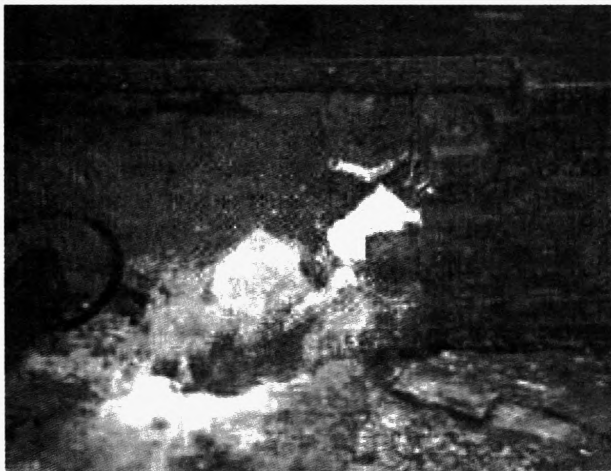
Lateral hydrostatic forces are generally not sufficient to cause deflection or displacement of a building unless there is a significant difference in water elevation on opposite sides of the wall in contact with the flood water. However, if there is significant difference, permanent deflections and damage to structural elements within the building may occur. Hydrodynamic forces are a function of flood water velocity and the building geometry and are capable of collapsing structural walls or floor systems. Figure 8 shows failure of a URM wall due to influence of flood water.

Figure 8 - Brickwork wall broken by flood water, Malton, U.K., November 2000 (Kelman and Spence [22])

Kelman and Spence [22] found that the vertical and diagonal yield lines comprise a sequence of horizontal and vertical segments (Figure 10) due to failure along the mortar joints rather than through the masonry units from conducting a yield line analysis for URM failing due to flood water pressures resulted from the combination of hydrostatic and hydrodynamic forces using small (area = 38 m²), medium (area = 55 m²) and large (area = 84 m²) cavity wall dwellings in U.K. This result is also confirmed from practical situations shown in Figures 8 and 9.

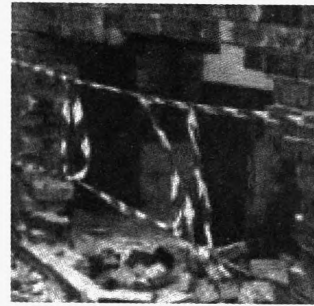
When the buoyant forces, which are also called as vertical hydrostatic force, associated with the flood, exceed the weight of the building components and the connections to the foundation system, the structure may float from its foundation. The force acted vertically through the centre of mass of the displaced volume. Impact loads are the direct forces associated with waves, as typically encountered during coastal flooding, or the impact of floating debris (Figure 9) within the flood

Figure 9 - Brickwork wall damaged due to impact force, Cambridge, U.K., December 2001 (Kelman and Spence [22])
