# Forensic Investigation on Design and Construction Failures

P. B. R. Dissanayake

**Keywords:** Failure, design, construction, investigation

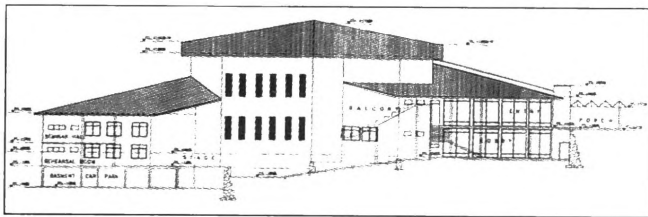
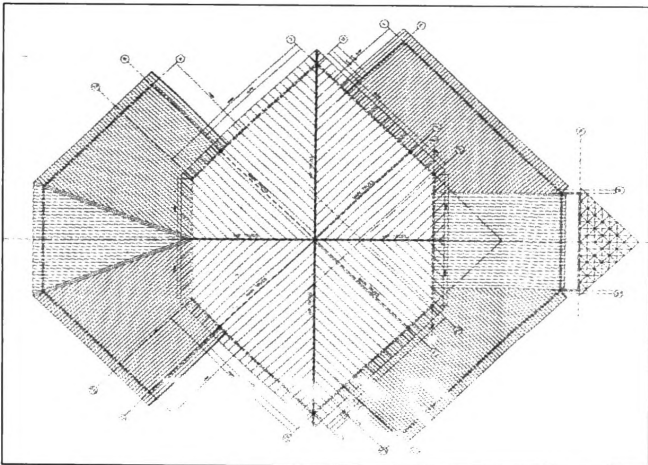
**Figure 4. Elevation and plan of the auditorium**

This case involves the construction of an auditorium, having a reinforced concrete structure with an asbestos roof, supported on steel trusses forming a dome type frame. Figure 4 shows the elevation and plan of the building.

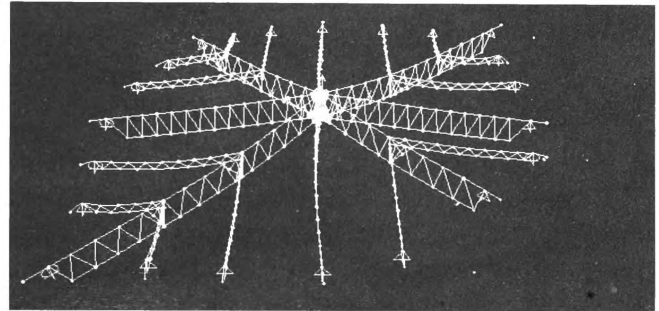
**Figure 5. Finite Element Model of the Truss System**

These 8 trusses are of three types (Figure A.1). Four main trusses of Type TR6 each of span 15.575 m, two shorter hip trusses of Type TR4 each of span 14 m, and two longer hip trusses of Type TR5 each of span 22.25 m. Several shorter secondary trusses (not shown) are connected to the hip trusses and the roof purlins, supporting the asbestos sheets, are laid on these trusses. A 3D finite element model used to analyze the truss system is shown in Figure 5
