# USE OF REVERTIBLE BIO-POLYMER SLURRY TO RETROFIT A SAND CHIMNEY DRAIN AT HAYS CREEK DAM

This paper deals with some of the processes and details that were behind the philosophy to upgrade this zoned embankment dam. The thrust of this paper is with regard to the geotechnical aspects that were dealt in retrofitting a sand chimney drain using a revertible bio-polymer to facilitate construction in this dam. The first of its kind to be successfully completed in an operating dam in this country.

Hays Creek dam is a rolled earth embankment 27m high at the deepest section and has a crest length of 77m. It is located at the Hunua Gorge, south of Auckland in New Zealand (Map 1). It impounds approximately 1 million cubic meters of water at top water level. The dam and the associated filter station are currently owned and operated by Watercare Services Ltd (WSL) for the water supply of Papakura district.

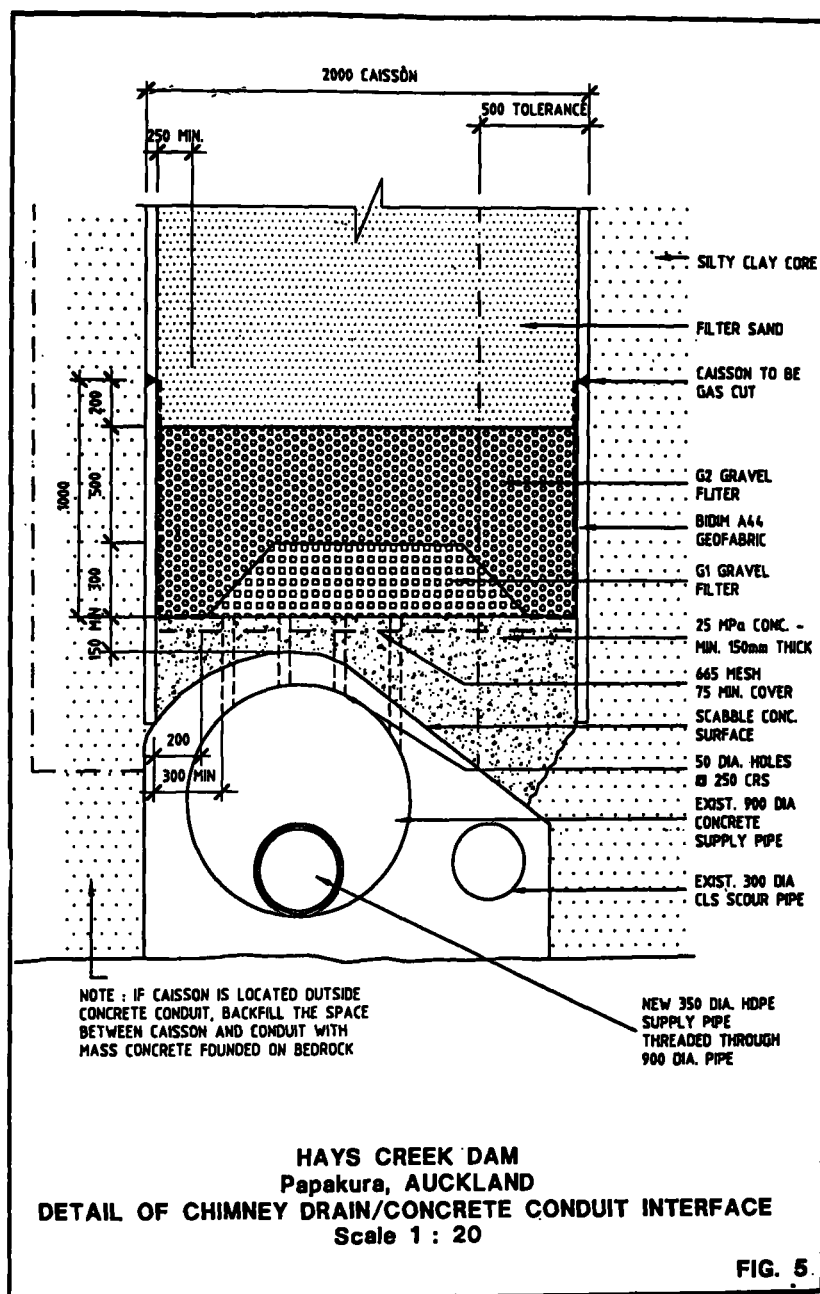
FIG. 4

concrete conduit. On reaching the required depth a 2m diameter steel caisson was lowered into the hole, and the slurry that remained in the caisson was pumped for storage and reuse. The location of the central drain and the detail of the connected works are shown in Fig 4. The contractor sank the caisson at exactly the intended location and no difficulties were experienced in carrying out this work.
