ENGINEERING GEOLOGY OF RANDENIGALA HYDRO POWER PROJECT SITE

A.U. Gunasekera

SYNOPSIS

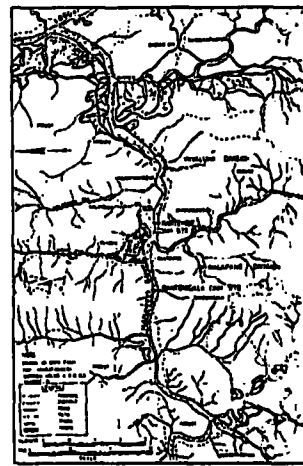
Randenigala Hydro Power Project Site is located in the valley of river Mahaweli between Victoria Dam and Minipe anicut (about 5.4 km upstream of Minipe anicut) about 35 km South East of Kandy. (see figures No: 1 and 2)

Figure 2 - Randenigala Project Area

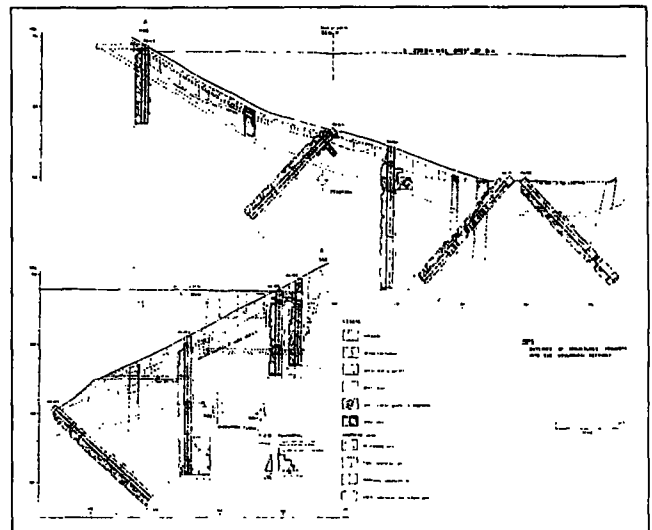
Figure 6 - Randenigala Dam Site Geo Technical Section A-A

Prior to the final excavation work the foundation depth for the shell area was expected to be identical with the upper border line of the highly weathered rock zone as given in figure No. 6-geotechnical section. Weathered bed-rock which fulfill the technical requirements for the shells of the rock fill dam was judged to be encountered in an average depth of 7-8 m generally, but adjacent to
