# Reviewing of Insulator Selection Criteria for Overhead Power Lines in Coastal Areas of Sri Lanka

A C S Wijayatilake

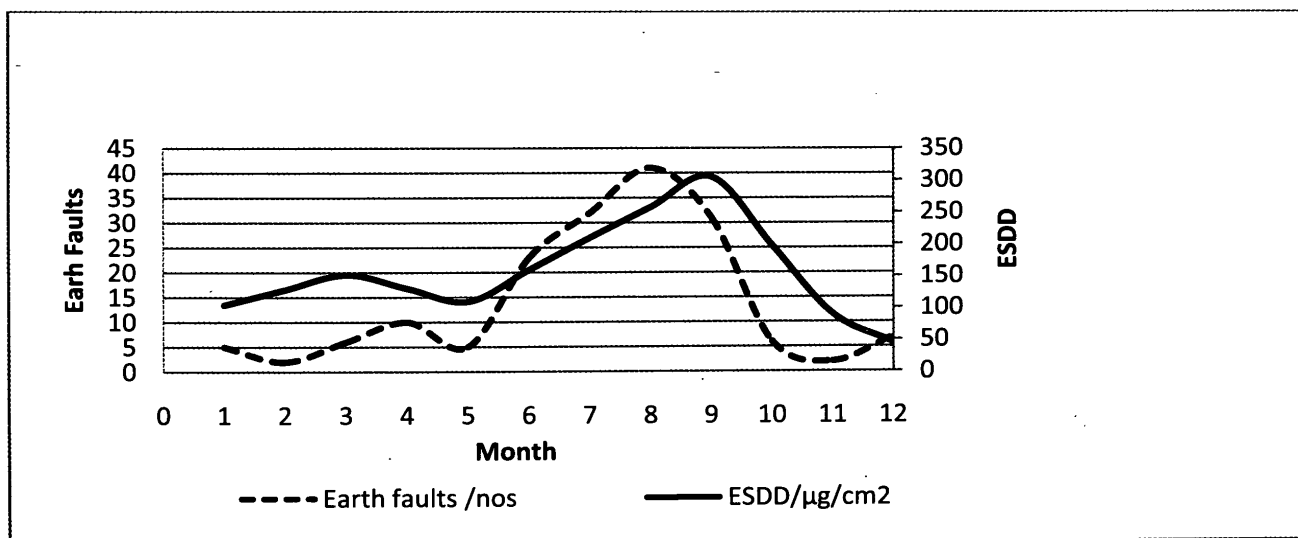
**Figure 1 - Relationship between monthly rainfall and earth faults reported during year 2010**

Table- 4 shows

- (i) The average ESDD is  $162\mu\text{g}/\text{cm}^2$  and the corresponding pollution category is II-medium level pollution. During the long dry season between March

and October the measured values are very high and the maximum measured value was  $305\mu\text{g}/\text{cm}^2$  and the relevant pollution category is III - Heavy pollution.

- (ii) Rainfall effects on the contamination level on insulators. Contamination on insulators due to marine pollution washes away naturally by rain.
- (iii) The Table-4 shows that the wind speed also effects on the degree of contamination. The contamination deposit rate is higher when the wind speed is higher. Since wind speed is higher at higher elevation its effect on insulators pollution on MV towers are higher than that on MV pole lines. Similarly, the effect on wind is very higher on insulator strings of transmission towers.

- (iv) According to the operational and maintenance experience, an increase in leakage current paths and hissing sound can be noticed on insulators in the dawns at the end of the dry season. The higher humidity and drizzling prevailing at the end of the dry season cause the contamination more conductive and increases leakage currents. That is the reason for considerable higher feeder trippings due to earth faults at the end periods of long dry seasons during the period May to October.
