# Hydraulic Stability of Submerged GSC structures

V.A.N. Soysa, D.M.D.T.B.Dassanayake and H. Oumeraci

**Abstract:** Geotextile Sand Containers (GSCs) are used for the construction of coastal structures as a low cost and softer alternative to expensive and hard structures made of concrete or rubble. However, the hydraulic stability of GSC-structures still needs to be investigated for a better understanding of the processes and the parameters of GSCs, which cause the failure. This study focused on the effect of the geotextile material, the sand fill ratio, and the inclination in GSC placement towards the hydraulic stability of submerged GSC structures. Four sets of specifically designed laboratory model experiments were carried out to study the influence of aforementioned parameters on the GSC stability. A new failure mode of GSCs was identified through the model experiments and named as "uplift and drift". From the test results (wave and damage analysis), new stability curves were developed and compared with each test scenario. The influencing parameters were quantified and the relative importance of each parameter for the hydraulic stability of submerged GSC structures was assess

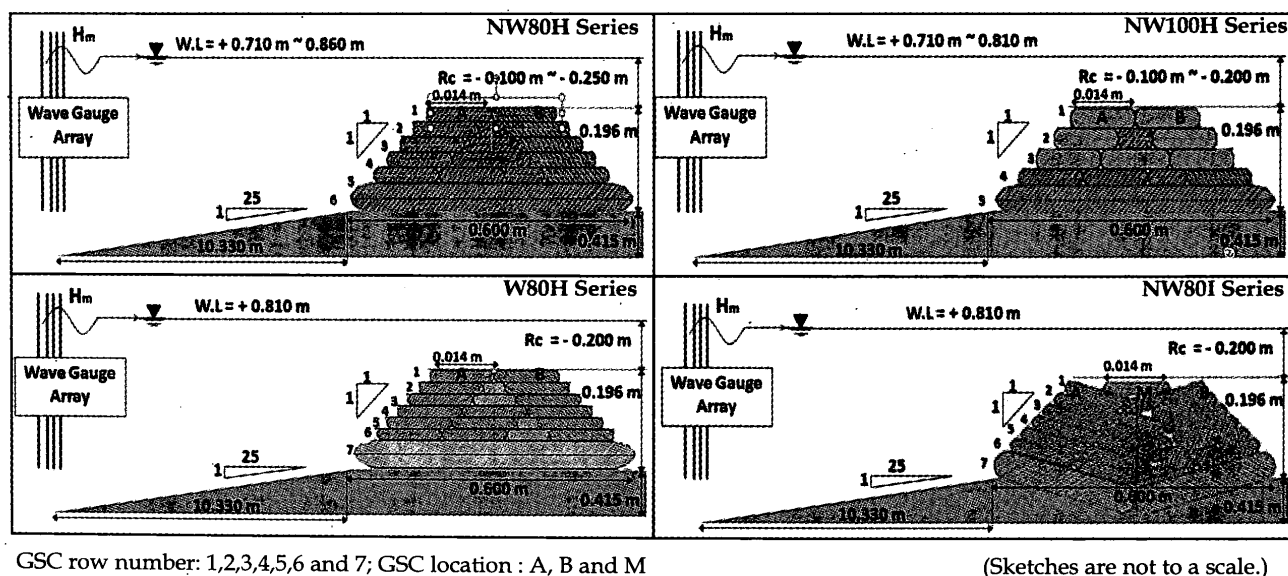
Figure 1 - Four test cases performed in laboratory model experiments

placed GSC (W80H); and Nonwoven, 80 % filled inclined GSC (NW80I).

Next, stability of the submerged model GSC structure were tested for selected wave conditions (both regular and JONSWAP spectrum) with different freeboards ( $R_c$ ) in such way that effect of identified key influencing parameters can be assessed. Figure 1 shows the four test cases as Nonwoven, 80 % filled, horizontally placed GSC (NW80H); Nonwoven, 100 % filled, horizontally placed GSC (NW100H); Woven, 80 % filled horizontally

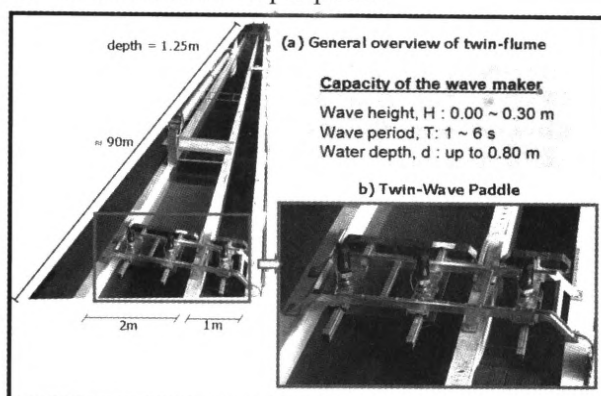
Figure 2 - Wave generation system in twin flumes at *Leichtweiß-Institut für Wasserbau* (LWI)

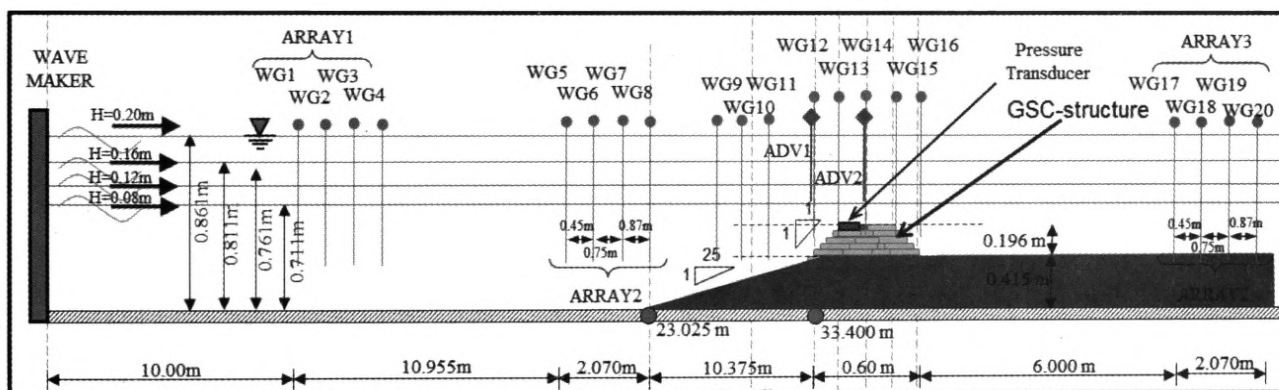
Figure 3 shows the experimental model setup and instrumentation of stability tests for GSC submerged breakwater at twin wave flumes in *Leichtweiß-Institut für Wasserbau* (LWI). The flumes are about 90 m long, 1.25 m deep, and one has a width of 1.0 m and the other one being 2.0 m wide and model tests were performed in 2m wide flume (Figure 2). Experimental model setup was instrumented with resistant type wave gauges, pressure transducer, and Acoustic Doppler Velocimeters for the measurement purposes.

Figure 3- Experimental Model Setup at *Leichtweiß-Institut für Wasserbau* (LWI)

During the testing process, wave data were recorded through 20 number of wave gauges. However, recorded data from Wave Gauge No 5-9 located at second array shown in Figure 3 were used for the reflection analysis in order to distinguish the wave characteristics at the beginning of the slope.

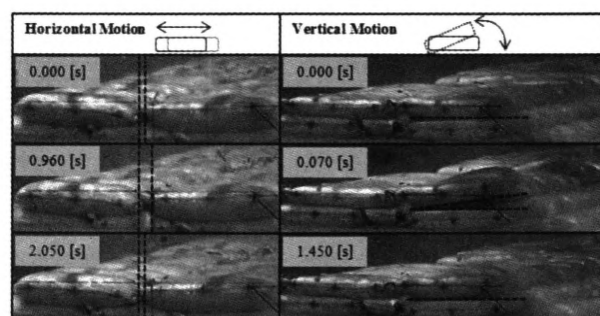
Figure 4- Incipient Motion

As shown in Figure 4 partial sliding and overturn occurred at the time where maximum force from the wave was exerted, but soon, GSC regained its initial location. This incipient

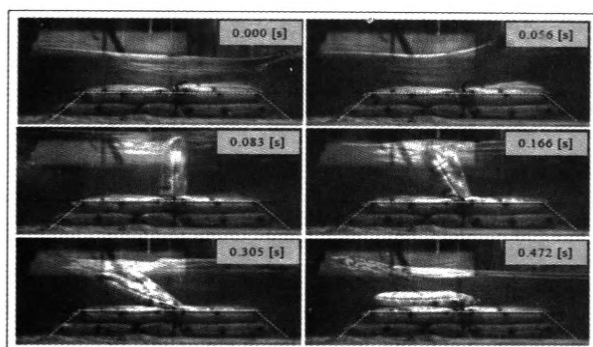
Figure 5 - Overturn Failure Mode of GSC

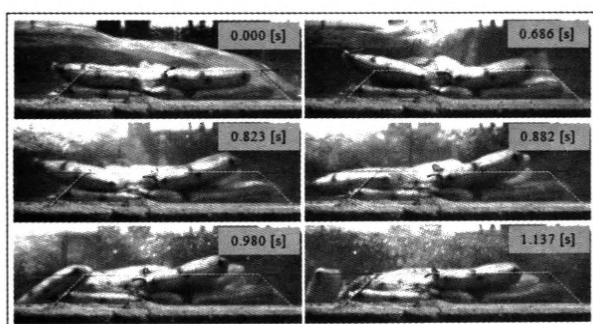
In sliding failure mode as shown in Figure 6, top GSC displayed lateral displacement relative to the lower GSC. Sliding can occur both instantly (complete detachment with one wave attack) and in progressive way (slight displacement per wave which leads to complete detachment after several wave attacks).

Figure 6 - Sliding Failure Mode of GSC

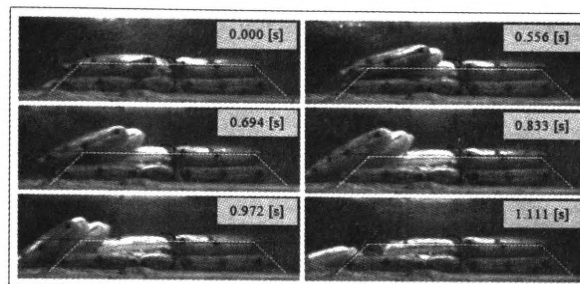
However, for certain instances as shown in Figure 7, it was observed that top GSC is lifted due to the pressure difference between the top and bottom side of the GSC and then drift with the wave where no surfaces of top GSC are in contacts with bottom GSC. Uplift and drift could be identified from the high speed video extracts, the Figure 8 shows the different between drifting and sliding.

Figure 7 - Uplift and Drifting Failure Mode of GSC

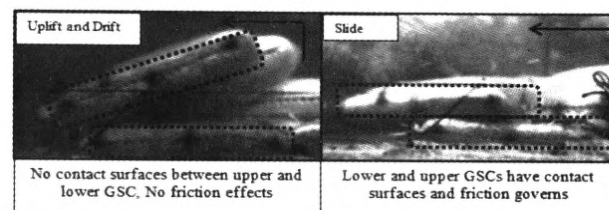
Figure 8 - Uplift and Drift in comparison with Slide

Therefore, in each case, bottom surface of the top GSC and top surface of the bottom GSC are in contact, friction between two surfaces can react against the failure. If not, restrained forces will not be mobilised, thus friction of the geotextile material does not count in failure.

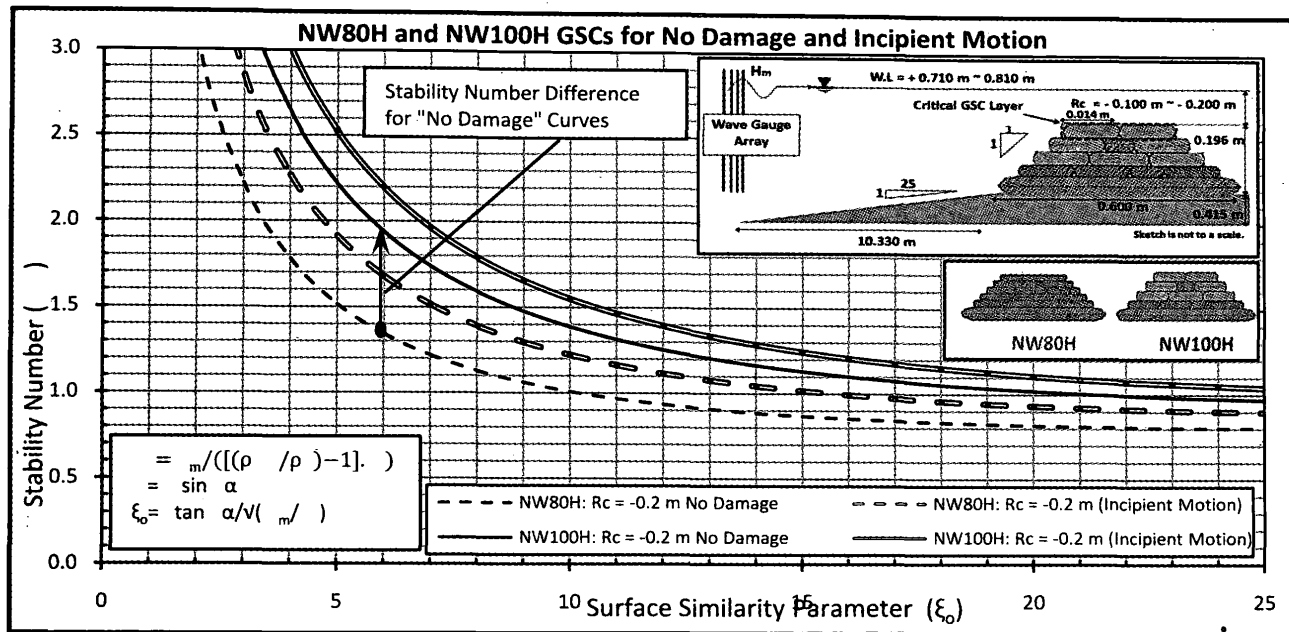
Figure 9 - Effect of the Geotextile Material - Stability Curves for NW80H and W80H

Apart from the consideration of forces, GSCs with higher sand fill ratio are less flexible and more in round shape resulting voids in the GSC structure. Therefore, higher permeability may also result higher stability for higher sand fill ratio. Stability increment observed for higher fill ratio is shown in Figure 9 with derived stability curves.

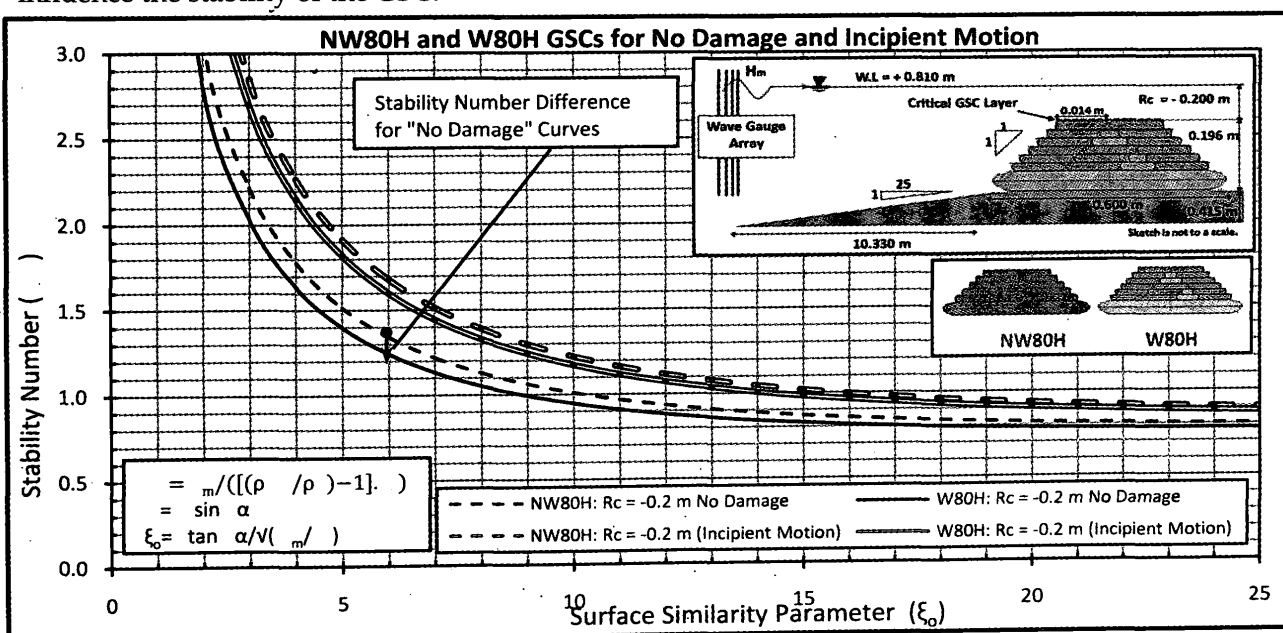
Figure 10 - Effect of the Geotextile Material - Stability Curves for NW80H and W80H

Effect of friction of the selected geotextile material against the hydraulic stability is investigated during the study. Friction angle for woven and nonwoven were  $16^\circ$ - $18^\circ$  and  $20^\circ$ - $26^\circ$  respectively. Accordingly, it is expected that W80H test series indicates a lower stability number as the friction angle is comparatively lesser. However, stability decrement of W80H compared to the NW80H shown in Figure 10 does not illustrate reasonable magnitude compared to the difference in friction angle of two material types. It implies that apart from the friction, other different properties of woven and nonwoven materials and processes influence the stability of the GSC.

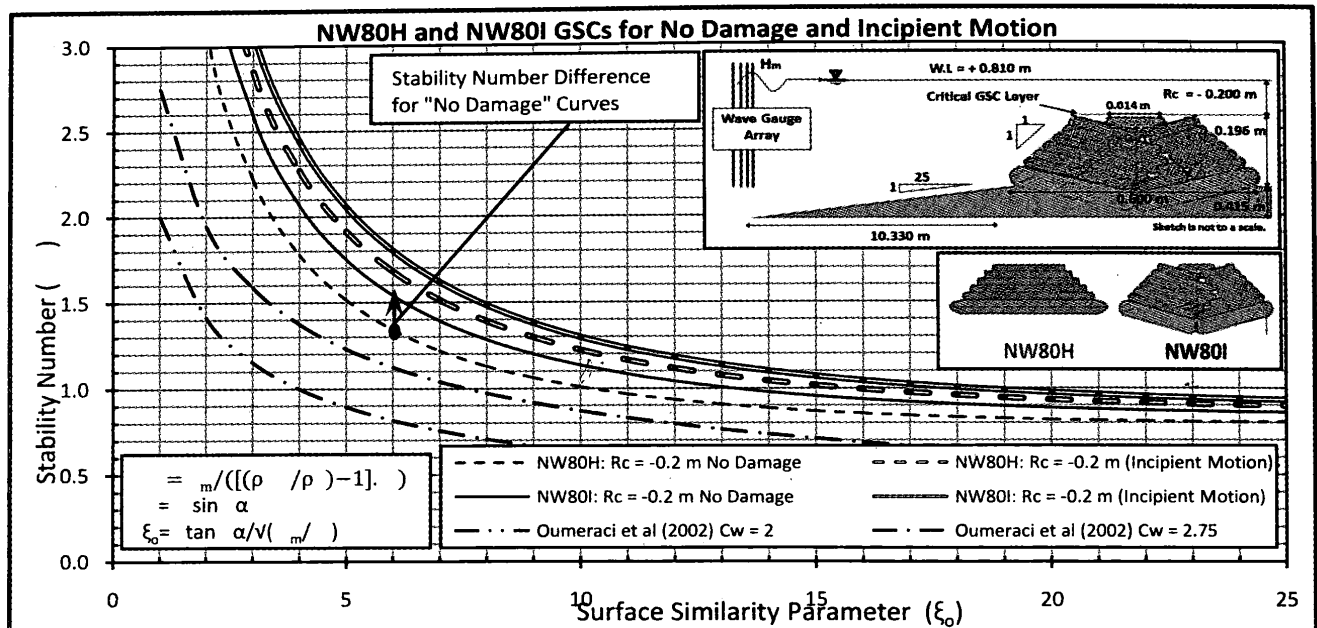
According to the 'No Damage' stability curves for NW80H and NW80I shown in Figure 11, small stability increment can be observed for the inclined GSCs. However, increment is trivial for the 'Incipient Motion' curve. It indicates that GSCs in both orientations, motion commence at the same wave conditions.

Figure 11 - Effect of the Inclination in GSC placement - Stability Curves for NW80H and NW80I

If failure mechanism of sliding is considered, inclined GSC shows higher stability, as if it is to be detached, GSC should initially move upwards. Nevertheless, inclined GSCs are prone to failure through overturning than horizontally placed GSCs.

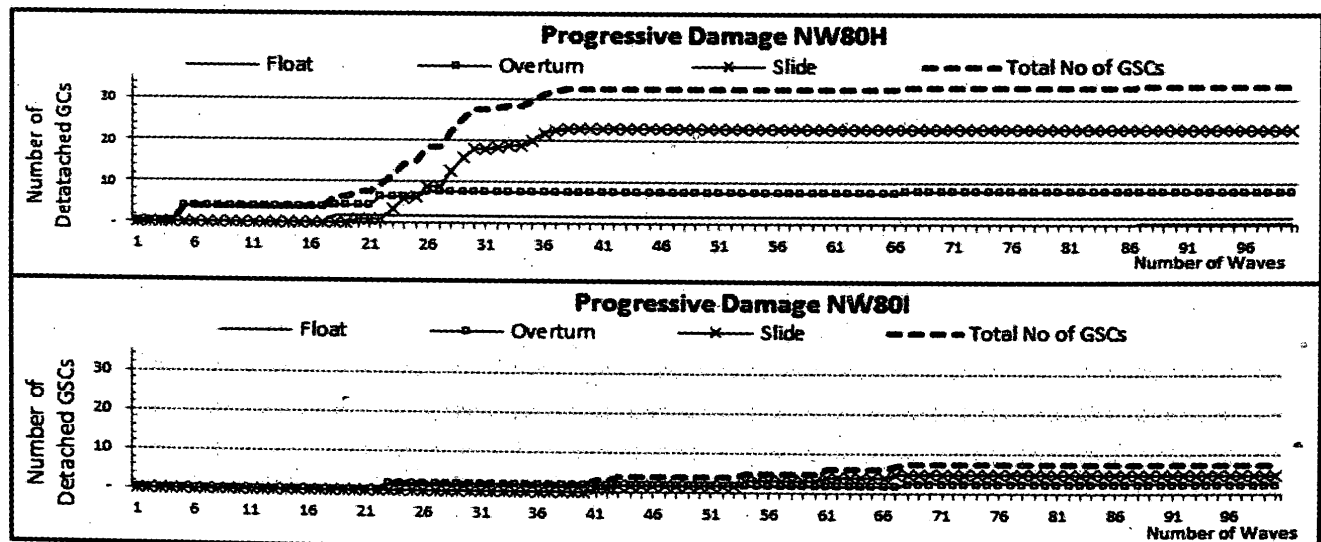
Figure 12 - Progressive Damage Analysis for NW80H and NW80I

However, during the model tests, it was noted that GSCs in inclined orientation shows incipient motion for a considerable time before detachment, as GSC has to be moved upwards in order to detach from the structure. Therefore, progressive damage analysis was carried out with the purpose of investigating the effect of inclination during the period the damage progresses. Figure 12 shows the progress of the damage in horizontal and inclined GSCs with respect to number of waves during two tests with almost similar wave conditions. Progressive analysis results implies that though the 'Incipient motion' stability curves for NW80H and NW80I didn't show reasonable difference, inclined placement GSC resulted comparatively lesser damage. Moreover, incipient motion had taken place for a considerable duration before the GSC was detached.

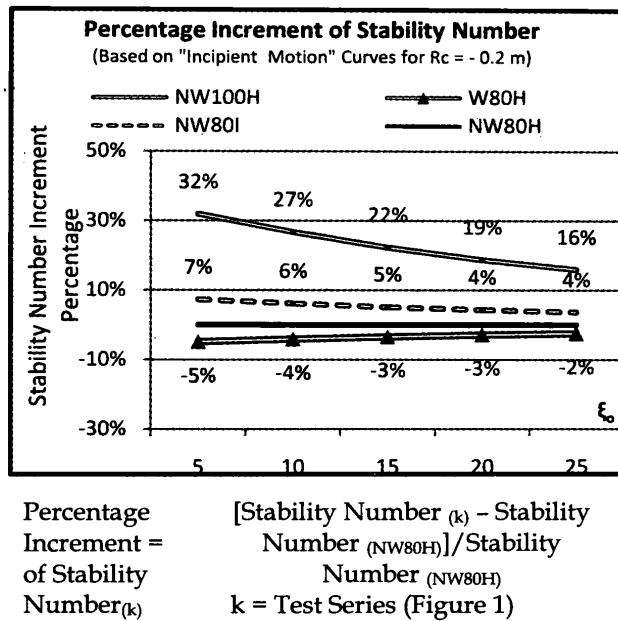
Figure 13 indicates that most influencing parameter for the stability of submerged GSC structure is the sand fill ratio and geotextile material is the least influencing parameter. Having higher sand fill ratio, GSC is more stable against sliding, overturning, uplift and drifting failure mechanisms. Apparently, higher permeability of the structure due to GSCs with higher sand fill ratio may also cause higher stability increment.

**Figure 13 - Effect of geotextile material, fill ratio and inclination of GSC placement against hydraulic stability of submerged GSC Structure**
